ICECAPS Weekly Report

Feb 2-8, 2014

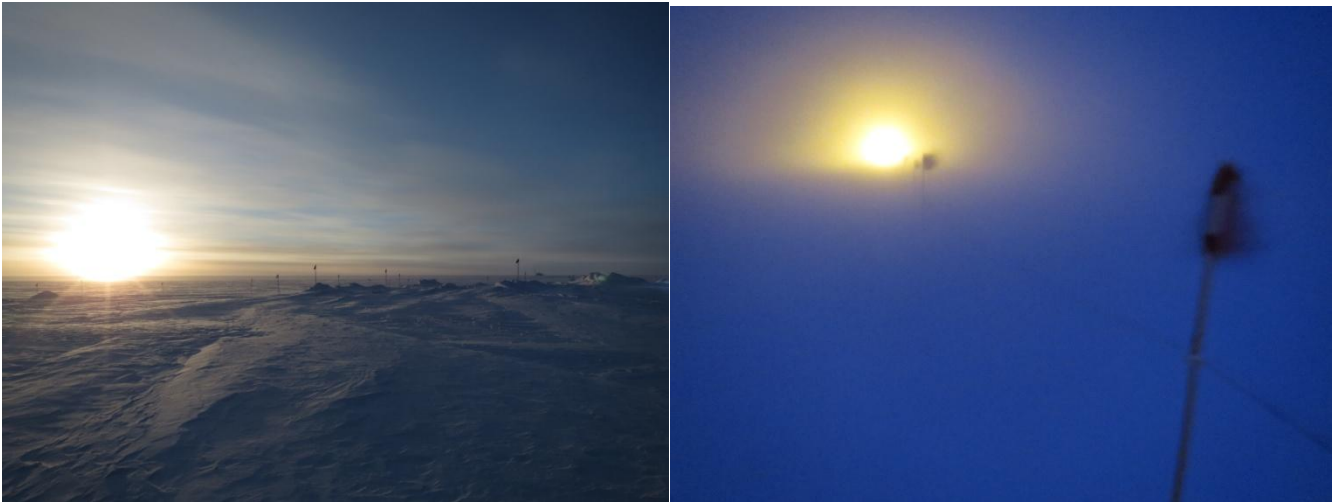
Weather at Summit was mixed this week (these pictures were taken 24 hours apart). Weather over the Strait remains horrible so we're still awaiting initial turnover flights. JM
