# ICECAPS Weekly Report

July 27 – August 2, 2015

Clair Von Handorf

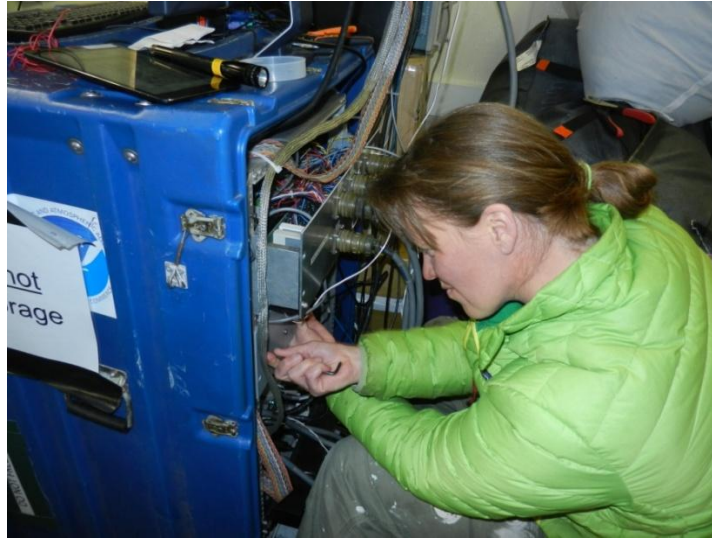
Trouble shooting on the MMCR –NS

- 7/28: 17:33z MMCR was shut down for troubleshooting. Monitor Patch Panel removed and

grounding wires were traced. The requested information was reported back to Duane and Matt. MMCR was restarted at 18:30z: +5V #1 and #2 are at +5.0V, Outdoor Temperature gauge at -8C. Pitch at 0.15.

- 7/29: 14:54z MMCR was shut down for troubleshooting. Other wires were traced and the information was reported. MMCR was restarted at 16:53z: +5V #1 and #2 are at +5.0V, Outdoor Temperature gauge at +200C. Pitch at 0.15.
- 8/1: 1156z MMCR was shut down. A 56K ohm resistor was installed between J1-12 to J1-16. MMCR was restarted at 12:14z: +5V #1 at +0.03 to +2V. Outdoor temperature at 0.98C. MMCR was rebooted twice with similar results.
