# ICECAPS Weekly Report

June 22 – 28, 2015

Sam Dorsi and Clair Von Handorf

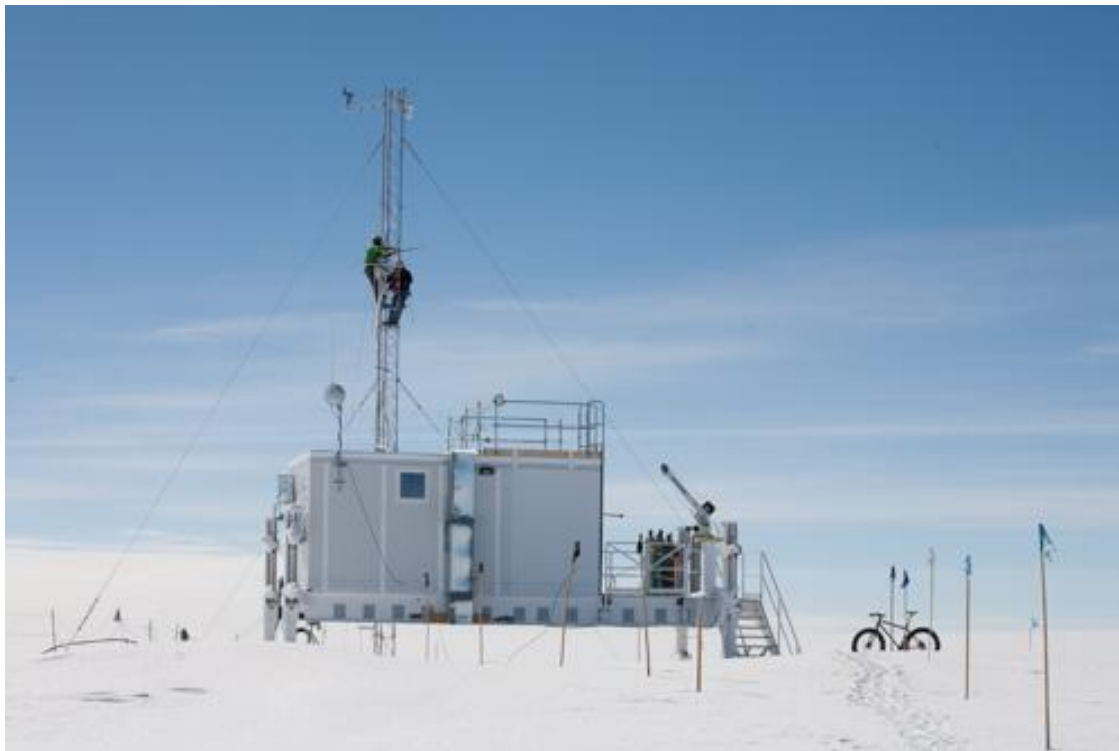
Sam Dorsi and Mike O'Neill working on the meteorology suite on the TAWO tower. --CVH
