ICECAPS Weekly Report

May 4 – 10, 2015

Sam Dorsi

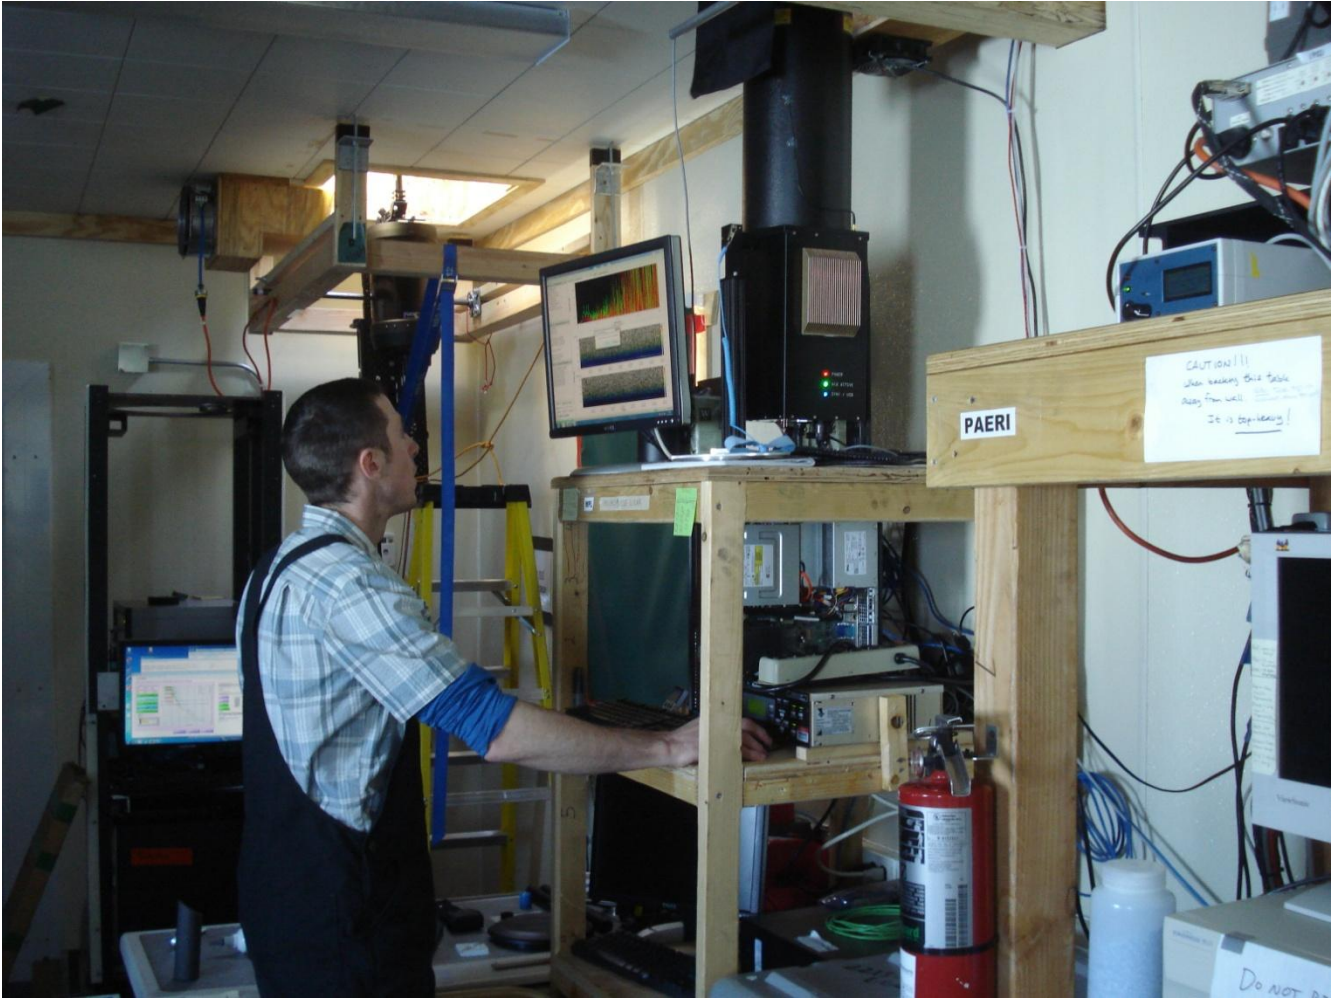
The MPL is shut down as Sam and Robert prepare for the USB bulkhead replacement. --RS

- Operating normally.
- 5/4: AMCS card error at 13:20z on 5/3. Data collection resumed at 22:00z on 5/4.
- 5/8: Replaced USB bulkhead from 13:21z to 16:32z, in an effort to eliminate frequent AMCS card errors. The replacement was undertaken by Sam Dorsi and Robert Stillwell and was successful. During the repair, an abraded cable (detector output signal) with exposed ground braid was discovered, patched with electrical tape, and re-routed with a 90-degree BNC connector to prevent future damage.
