ICECAPS Weekly Report

November 28 – December 4, 2016

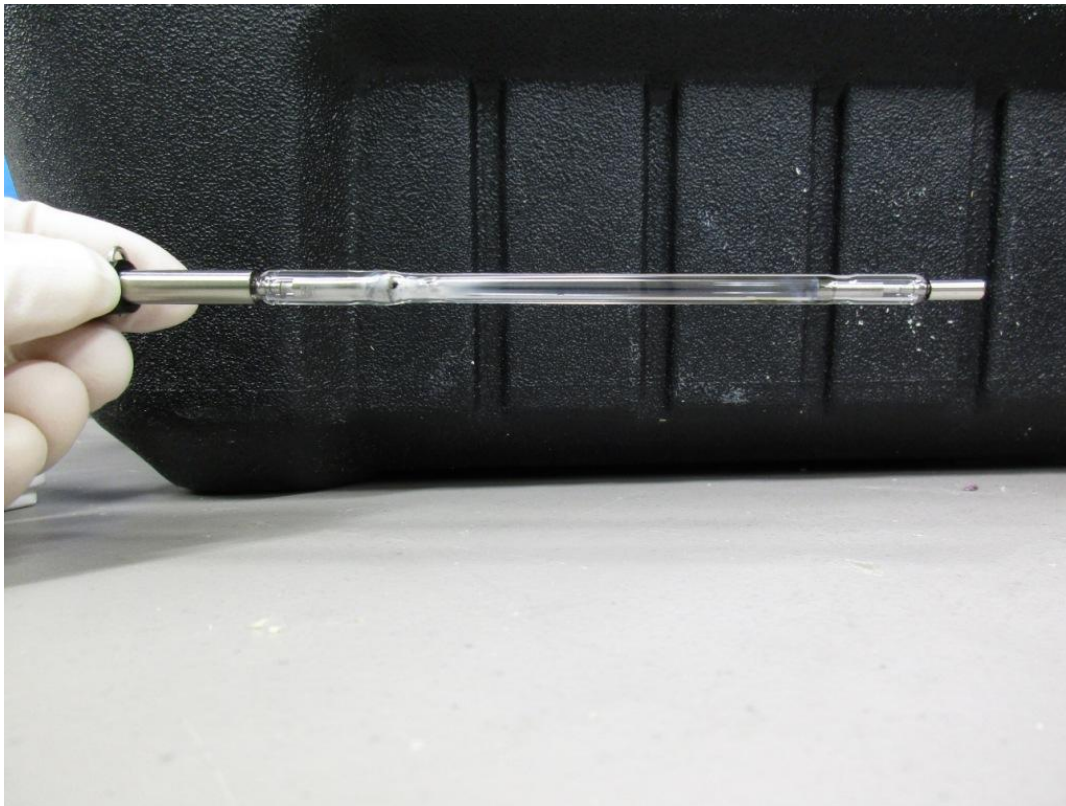
The used Laser 1 flash lamp, displays white and tan glass smoking from a productive lifetime pumping the CAPABL laser. SWD.

- Operating normally.
- 12/1: Flash lamp was replaced in Laser 1 (17:14z) using lamp labeled 'NEW 6-17-2016'. During the first minute of Laser 1 operation, tech noted a steady decrease in peak detector counts, and a visible dimming of the CAPABL beam. Out of concern for the system, tech stopped the laser and contacted PIs. This degradation in power was repeated during diagnostics with Robert. He concluded that thermal transients were causing poor pump/conversion efficiency-- the first time this effect had been identified in this particular system. As the system continued to warm in test operations, the laser power increased to normal levels. CAPABL resumed full operation on Laser 1 at 19:10z.
- 12/2: After testing on both Laser 1 and Laser 2, Robert confirms that system is operating

normally. Laser 1, which has the greater output power, will remain in active use.
