# ICECAPS Weekly Report

August 21 – 27, 2017

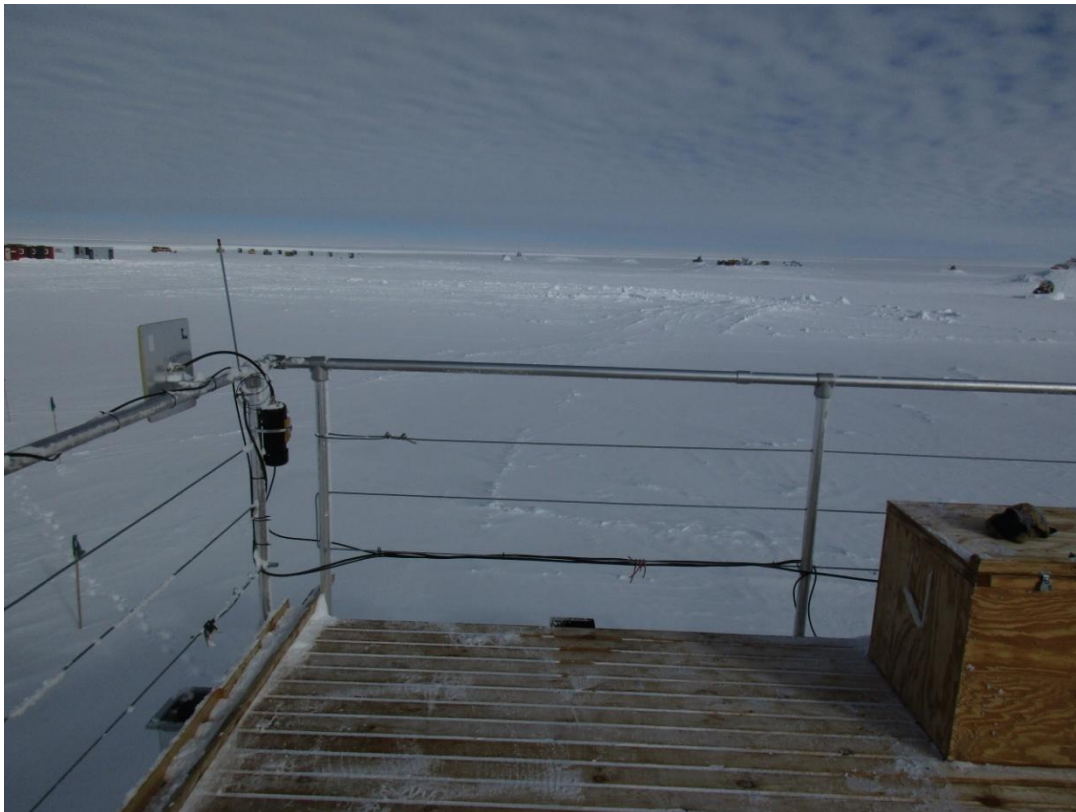
The newly replaced IceCAM cable run is well-protected from damage from snow removal. SWD

- Operating normally.
- 08-25: IceCAM outdoor ethernet cable replaced.
