# ICECAPS Weekly Report

February 13 – 19, 2017

Sam Dorsi and Hannah James

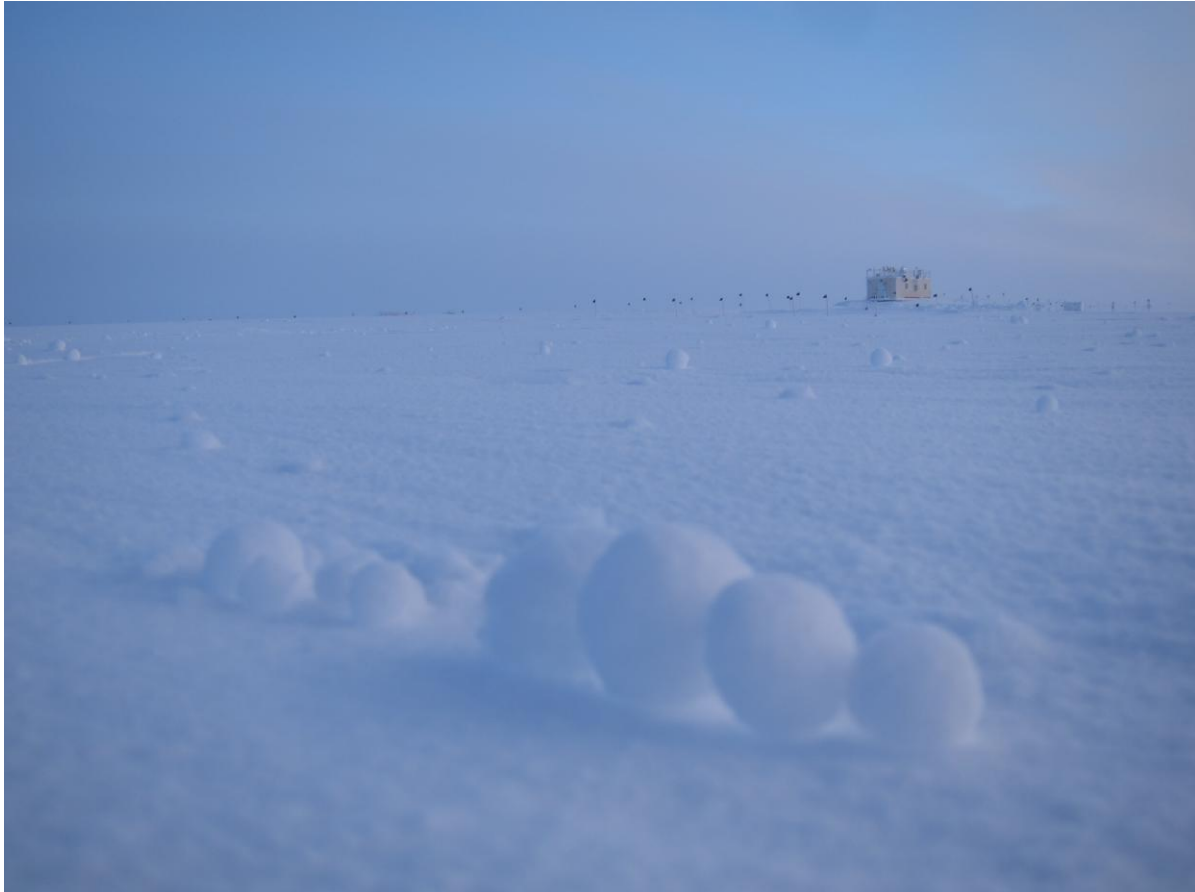
Clusters of yukimarimo gather on the outskirts of camp (2/16). SWD.
