# ICECAPS Weekly Report

February 20 – 26, 2017

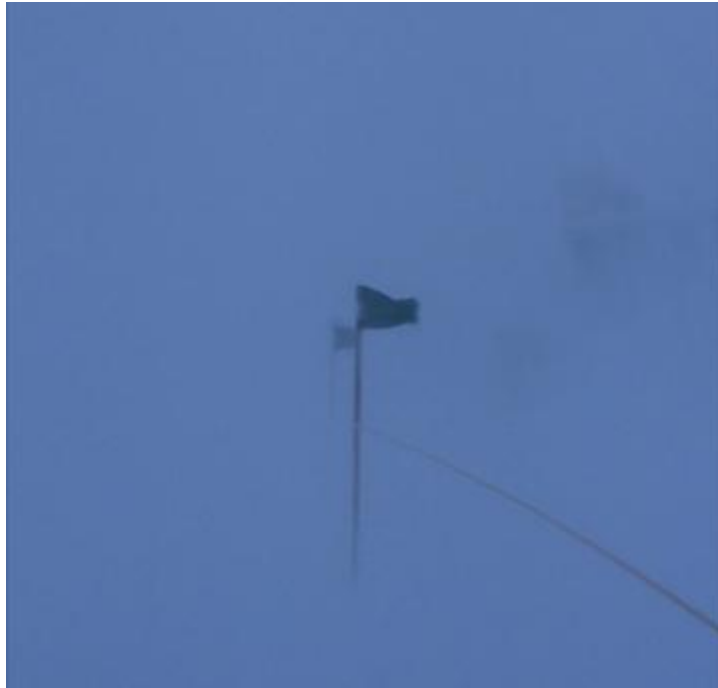
Low visibility all week limited photo opportunities. -HJ
