# ICECAPS Weekly Report

February 6 – 12, 2017

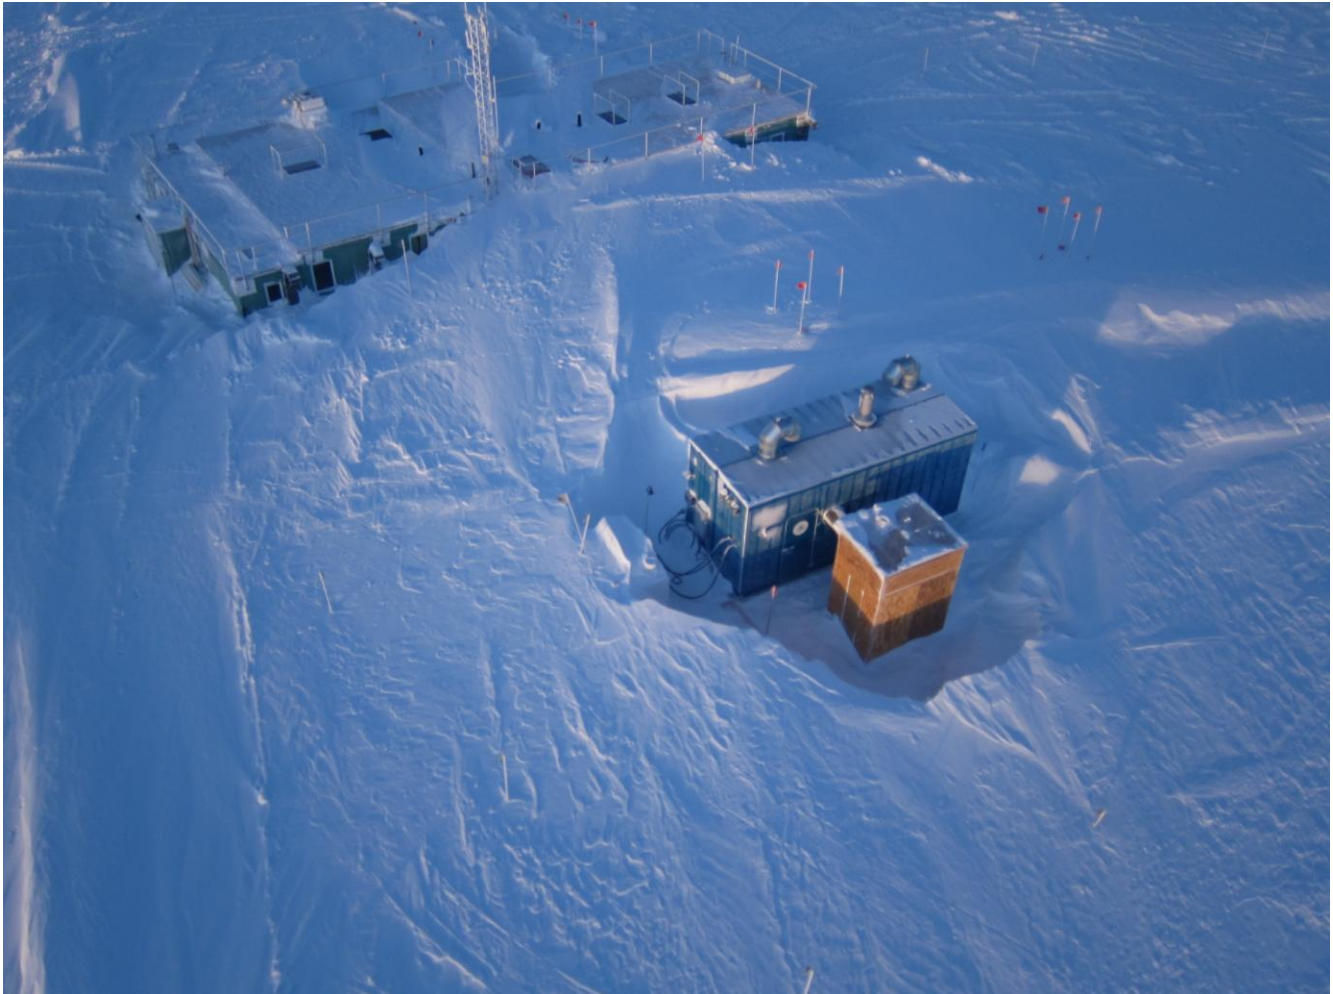
Snow drifts rise around the Green House and microturbine buildings. SWD.
