ICECAPS Weekly Report

January 23 – January 29, 2017

Sam Dorsi

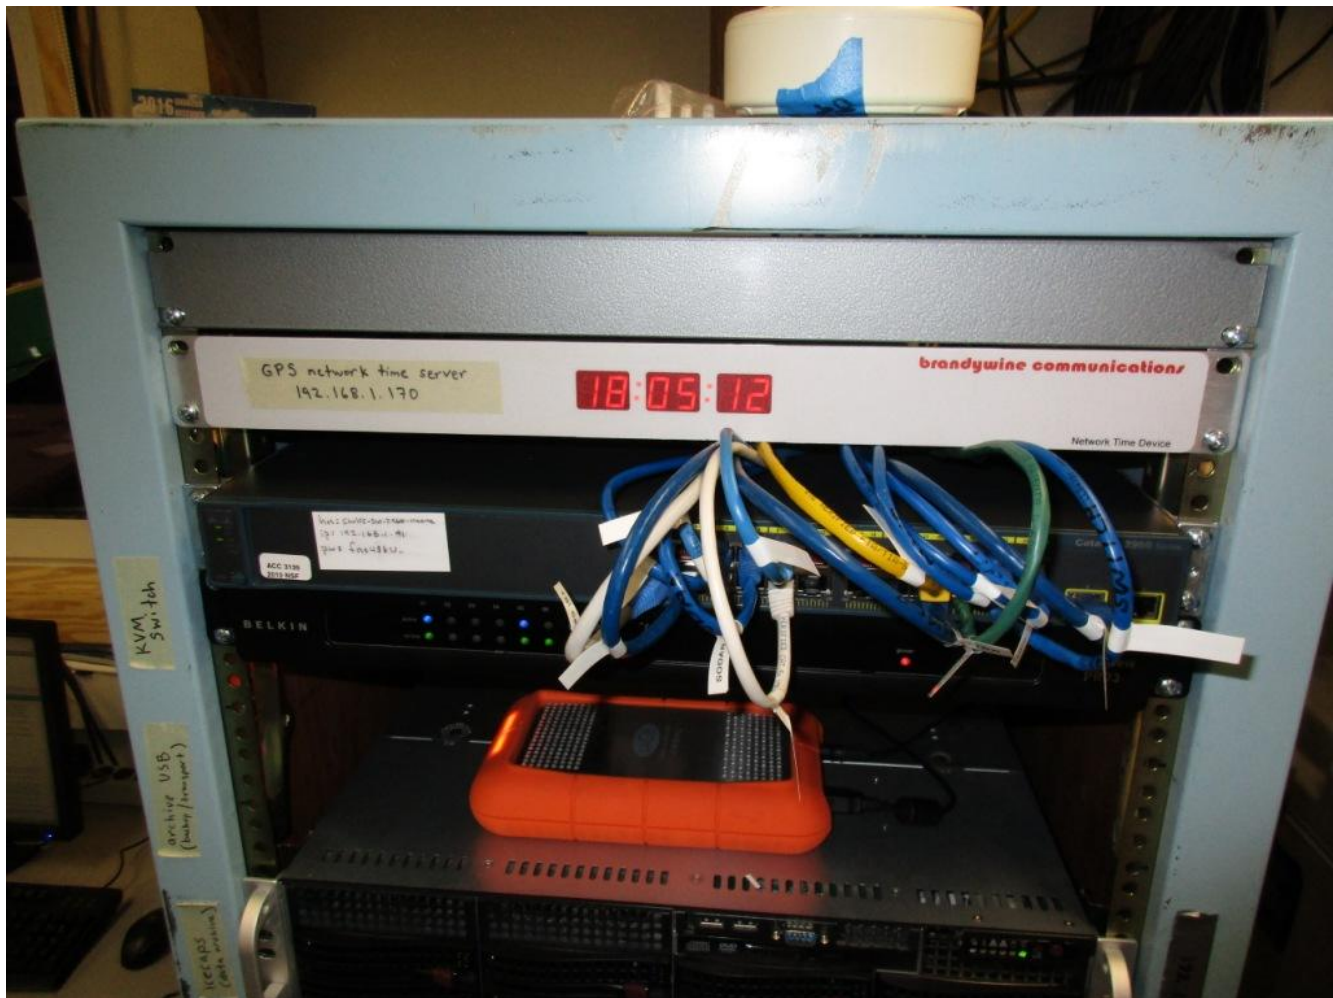
The newly installed MSF network switch is populated with individually labeled cables. SWD.

- 1/24: The MSF network switch was swapped from 17:35 to 17:53z, resulting in an 18-minute outage. The previous unit had been steadily failing and the replacement was installed to avoid a less-controlled outage at a future date.
