ICECAPS Weekly Report

July 10 – 16, 2017

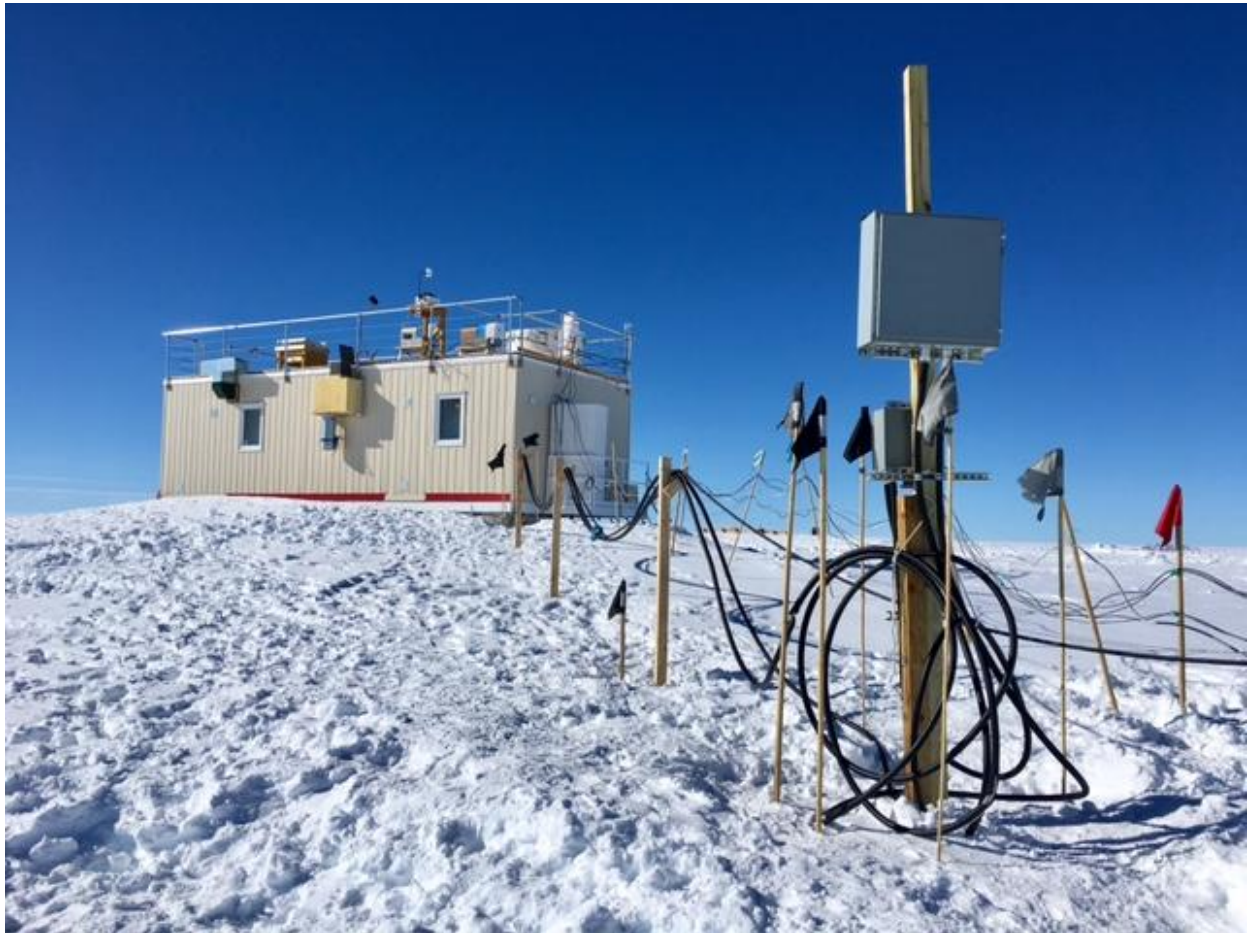
The MSF power boxes and cables were raised above the drift forming on the south side of the MSF.
(Photo taken 07-11 by Marci Beitch)

On Tuesday, 07-11, height was added to the MSF power mast and the power boxes were raised to avoid being buried throughout the coming winter. On Sunday, 07-16, Summit Station experienced an unplanned power outage when the Microturbine shut down at 08:27Z. Power was restored within 8 minutes by powering on the Emergency Generator at 08:35Z.
