ICECAPS Weekly Report

September 18 – 24, 2017

Sam Dorsi

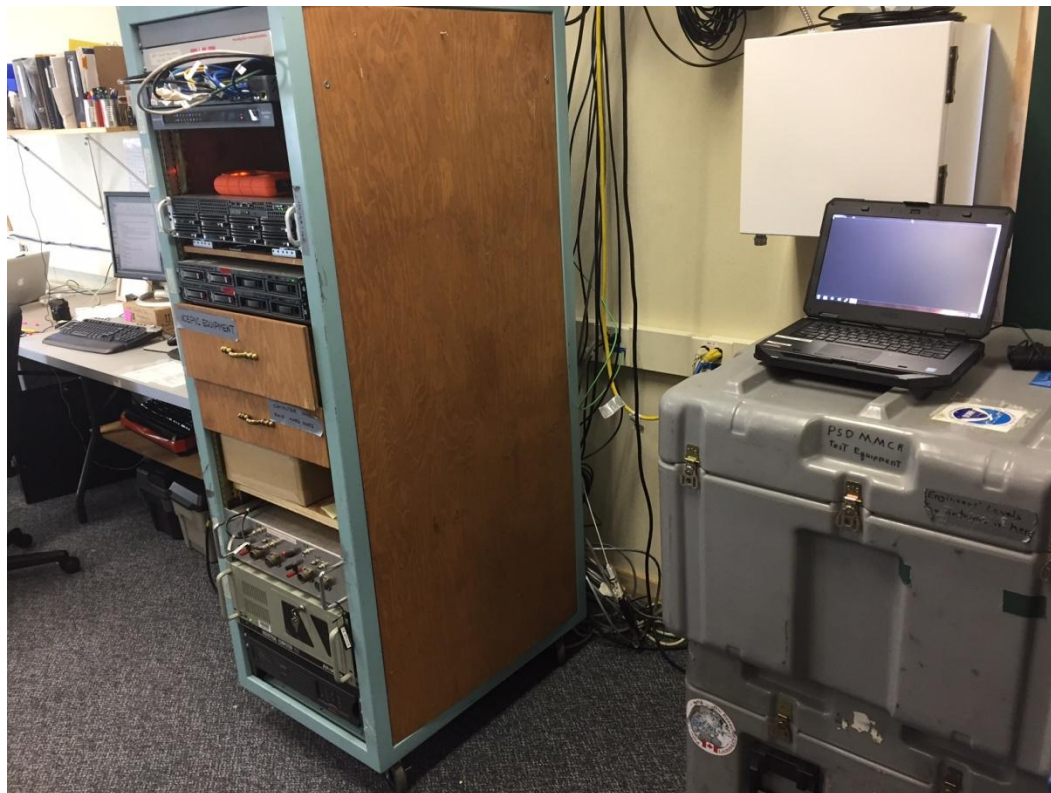
The MMCR cases provide a workstation for diagnostics on the POSS and Telebyte unit. SWD
