ICECAPS Weekly Report

September 25 – October 1, 2017

Sam Dorsi

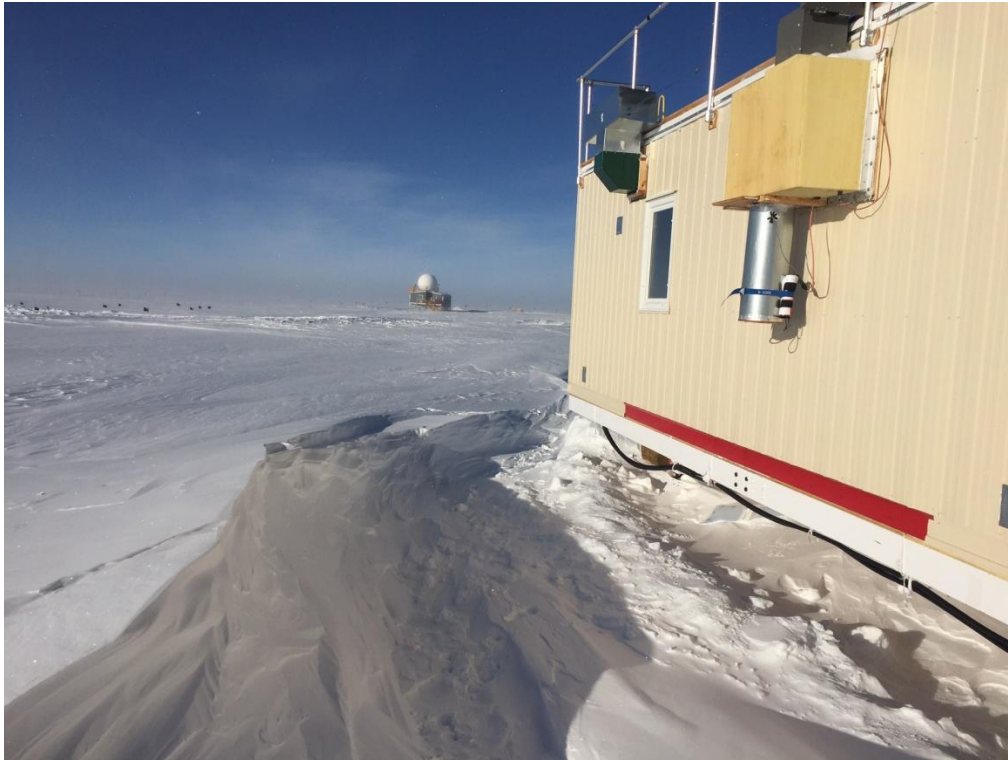
Following last week's winds, the drift to the south of the MSF is now a meter high. SWD
