ICECAPS Weekly Report

Jun 4 – Jun 10, 2018 Rex Nelson and Marci Beitch

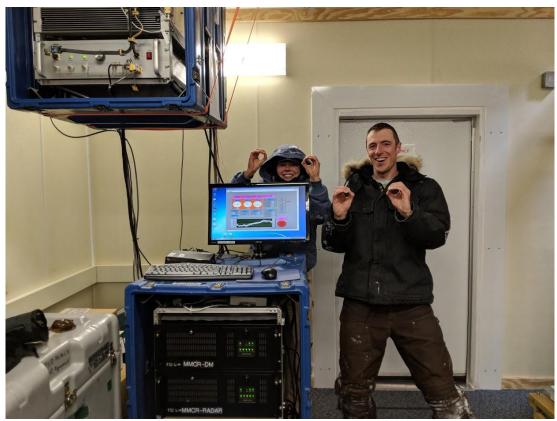
Incoming PFS technician Mara Menahan and Science Project Manager Sam Dorsi completed a leveling of the MSF structure. The MMCR pitch and roll each read 0.00. (Photo: Marci Beitch, 2018-06-09)

- Operating normally.
- 06-08 11:00Z: NetCDF errors occurred and were cleared at 12:45Z. Reboot not performed.
- 06-08 13:00Z and 19:00Z: NetCDF errors occurred and were cleared on 06-09 at 13:15Z. Reboot not performed.
- 06-09 11:30-13:05Z: MSF leveling performed.
 - o MMCR parameters before level: Pitch -0.21 flashing to -0.32, Roll 0.00 flashing to 0.11.
 - o MMCR parameters after level: Pitch 0.00, Roll 0.00.
- 06-09 14:00Z: NetCDF errors occurred and were cleared at 14:14Z. Reboot not performed.
- 06-09 15:00Z: NetCDF errors occurred and were cleared at 17:58Z. Reboot not performed.
- 06-09 18:00Z: NetCDF errors occurred and were cleared on 06-10 at 13:18Z. Reboot not performed.
- 06-10 14:00Z: NetCDF errors occurred and were cleared at 14:32Z. Reboot not performed.
- 06-10 15:00Z: NetCDF errors occurred and were cleared on 06-11 at 12:34Z. Reboot not performed.
