ICECAPS Weekly Report

February 26 – March 4, 2018 Rex Nelson

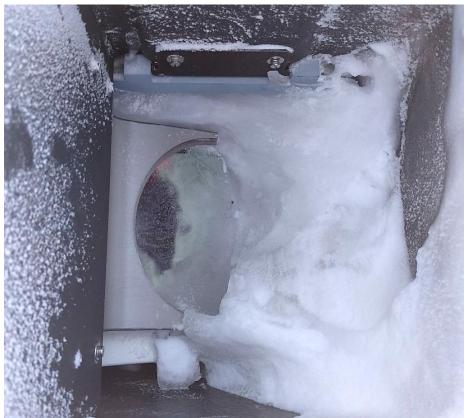
The Ceilometer window after intense storms last week.

- 02-26: Window mostly covered in ice. Warnings in status message: "Receiver failure (A)Window contaminated (W)Battery low (W)Laser power low (W)Receiver optical cross-talk compensation poor"
- 02-27 through 03-02: Window mostly covered in ice. Blower not working. Warnings in status message: "Receiver failure (A)Voltage failure (A)Window contaminated (W)Battery low (W)Laser power low (W)Laser temperature high or low (W)Voltage high or low"
- 03-01: Blanket wrap removed from instrument. Access panel found frozen shut and bulging from ice.
- 03-02: Ceilometer disconnected at ~1530Z and moved indoors to thaw.

- 03-01: 14:15-15:15Z Heavy equipment clearing snow drift on west side of MSF.
- 03-01: ~14:00-14:30Z Cleared snow accumulation from MSF roof.
- 03-02: 19:15-2015Z Heavy equipment used to lower ceilometer from roof and clear more snow on west side of MSF.
