ICECAPS Weekly Report

January 15 – January 21, 2018

Hannah James

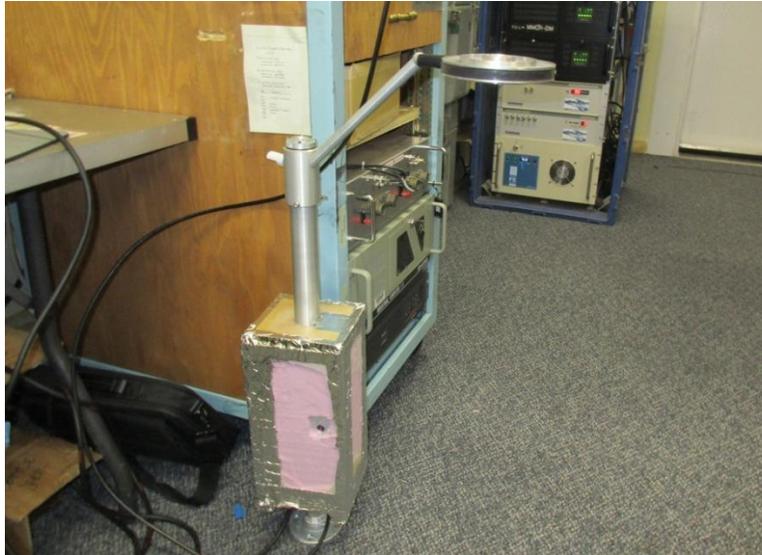
The Hotplate has returned to the interior of the MSF to troubleshoot miscellaneous errors. -HJ

- Offline since 2018-01-11 due to Error 1073807339 (timeout expired before operation completed).
- 01-19: Disconnected and brought inside.
