# ICECAPS-ACE Weekly Report

December 9-15, 2019

Jess Ackerman

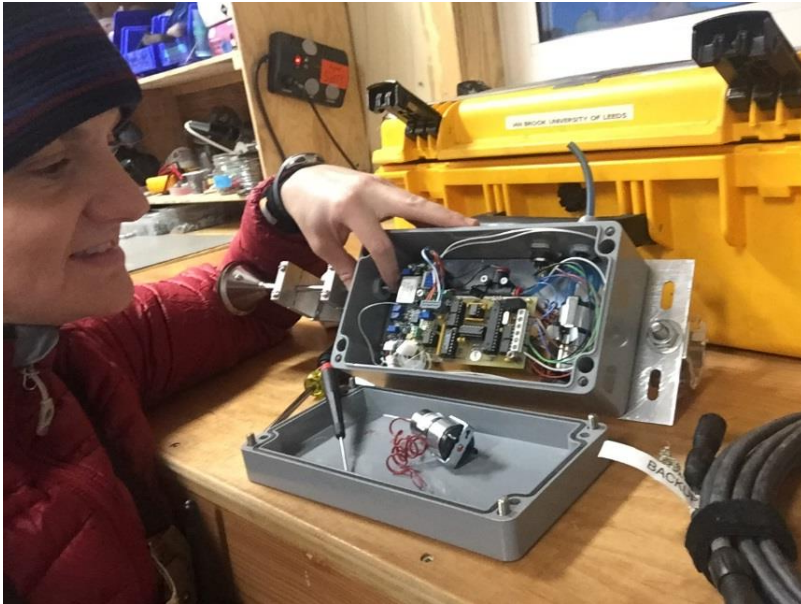
*Left: 2019-12-10: ICECAPS Tech Jess replacing the pump in the CLASP.*

- 2019-12-10 1306Z: No CLASP pump noise on roof. Data collection stopped at 1915Z the night before. CLASP was re-plugged in hoping to reset but eventually brought inside at 1328Z for pump replacement. Reinstalled on roof same day at 1538Z. Exhaust hose also replaced.
- 2019-12-11 1240Z: Still no consistent data. CLASP brought inside for further diagnostics.
- 2019-12-12 1525Z: Troubleshoot testing indoors with PI commenced.
- 2019-12-13 1500-1615Z: Pump calibration completed. CLASP reinstalled on rooftop 1618Z.
- 2019-12-14 1250Z: No pump noise. Notified PI.
