ICECAPS-ACE Weekly Report

January 6-12, 2020

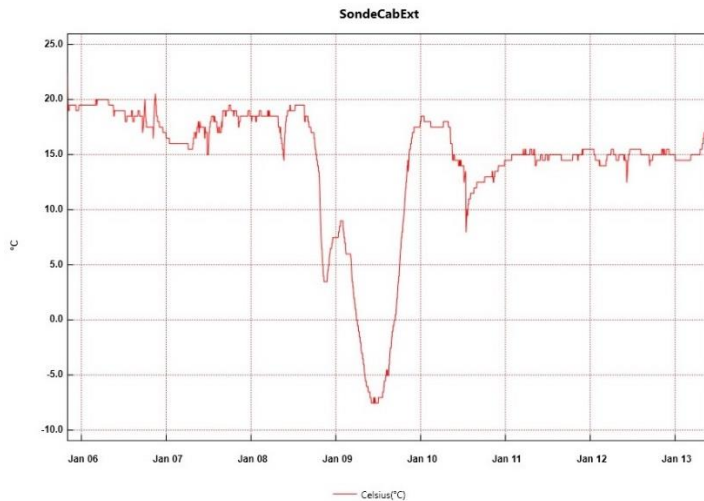
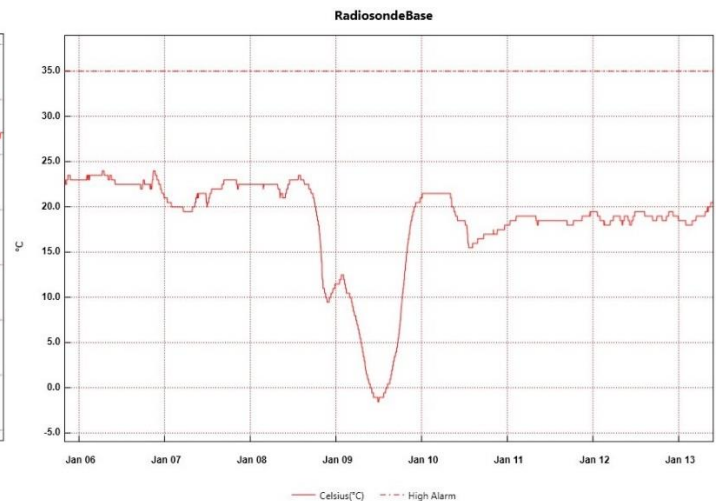
- Twice daily launches, except not attempted on 01/09 AM due to high winds (45 knots). The sonde on 01/10 PM terminated itself after successful launch; no re-launch due to high winds.
- See charts below for temperatures outside and inside the radiosonde cabinet over the last week.

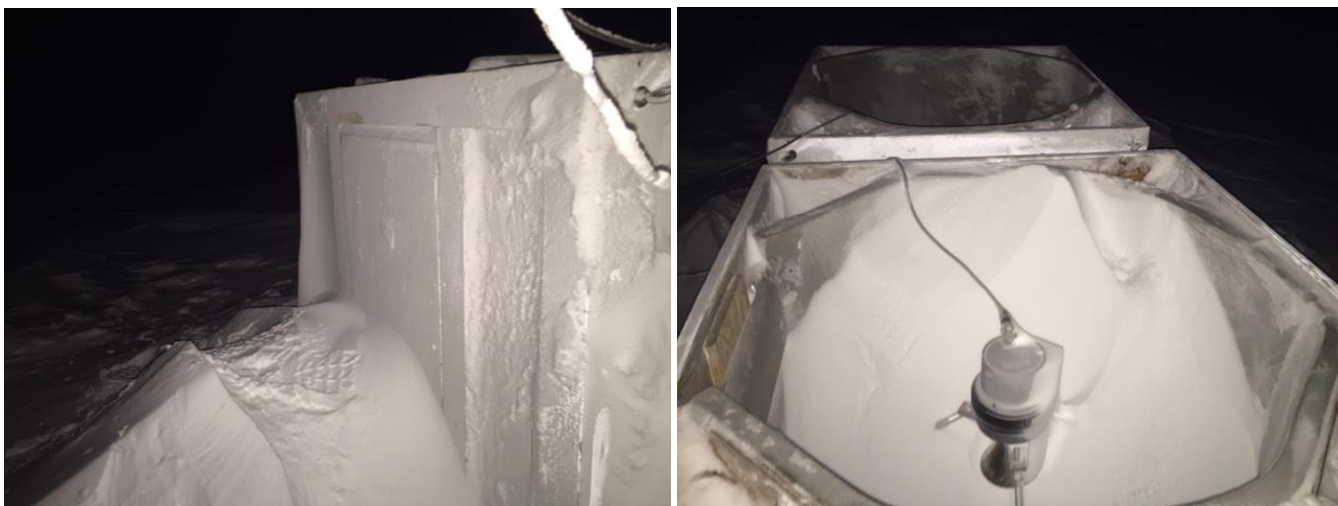
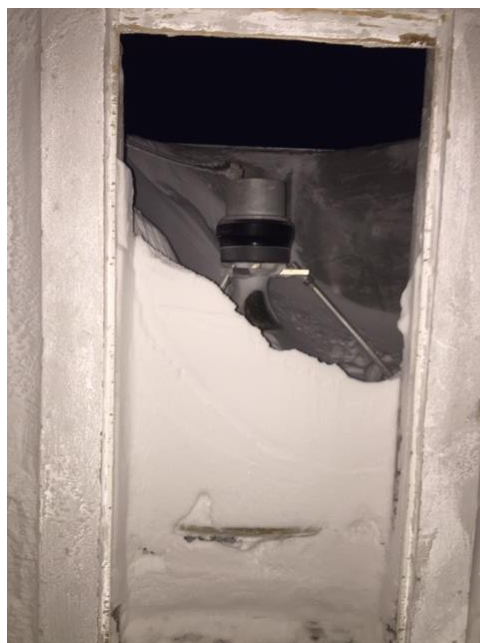
- 2020-01-07 1356-1438Z: Cleaned SODAR. North dish was $\frac{1}{4}$ full. Extensive drift maintenance completed.
- 2020-01-10 & 11: Poor data noted but too windy to clean.
- 2020-01-12 1152-1252Z: Cleaned SODAR. Heavy drifting. Both dishes $\frac{1}{2}+$ full.

2020-01-12 1152Z: SODAR heavy drifting (above, left) at the north dish front door, (above, right) facing north looking into south dish, and (below) looking into south dish front door. Lots of shoveling occurred.
