ICECAPS-ACE Weekly Report

February 17-23, 2020

Nate Bowker

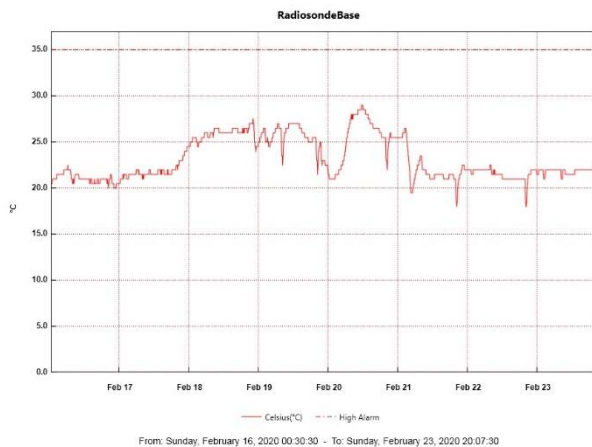
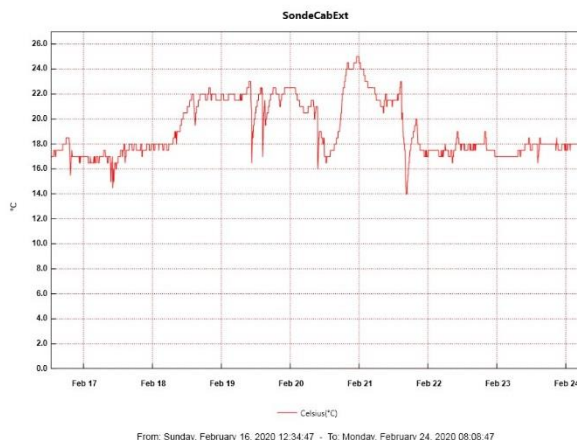
- Very cold temps this week have resulted in generally low burst altitudes. Average burst altitude for this week = 15833.5m, with burst altitudes ranging from 12187m on 2/23 to 21371m on 2/19.
- See charts below for temperatures inside and outside the radiosonde cabinet over the last week.
