# ICECAPS-ACE Weekly Report

March 23 – March 29, 2020

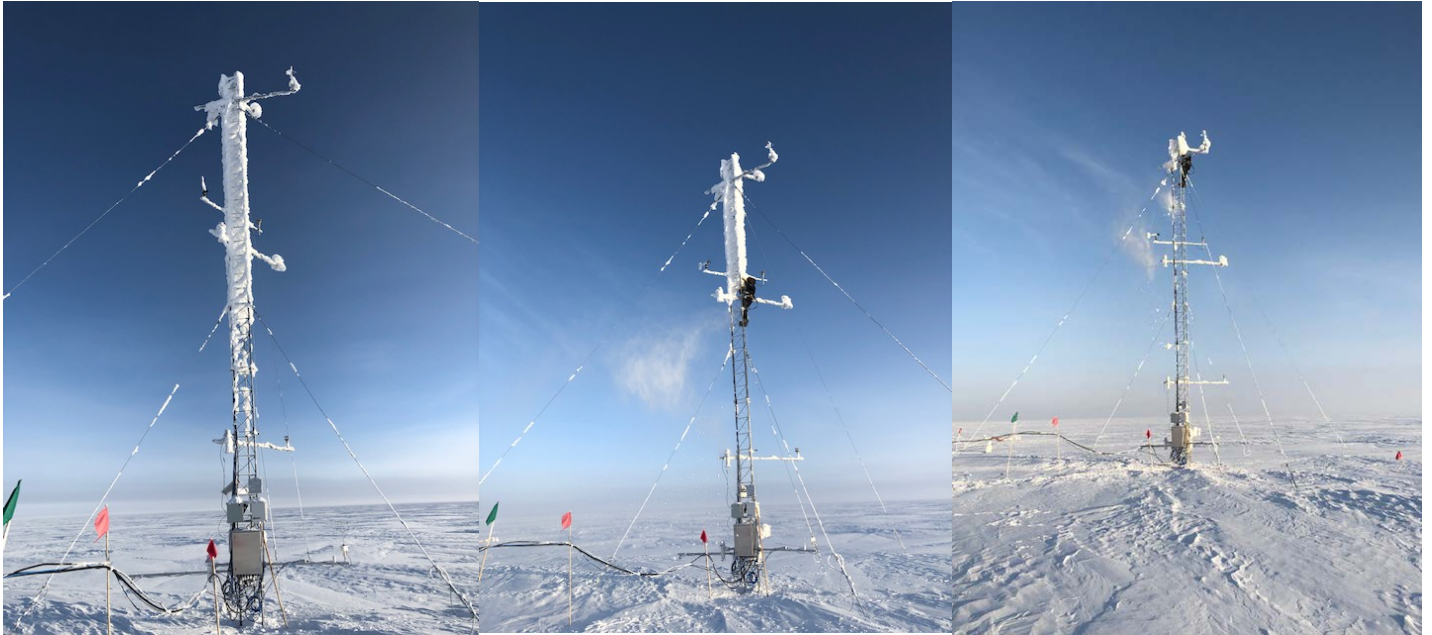
*Mara cleans the TAWO tower in order to investigate flux instrument cables. Photos Nate Bowker*

- 2020-03-23 and 2020-03-26: Performed multiple tower climbs to inspect instruments, junction boxes, and cabling for damage that could cause a power supply failure.
- Still trying to track down materials to provide protection for the AC power input to the new power supplies.
- Instruments with power operating normally.

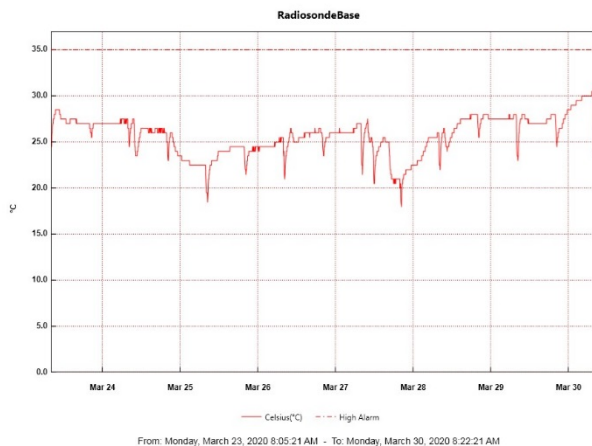
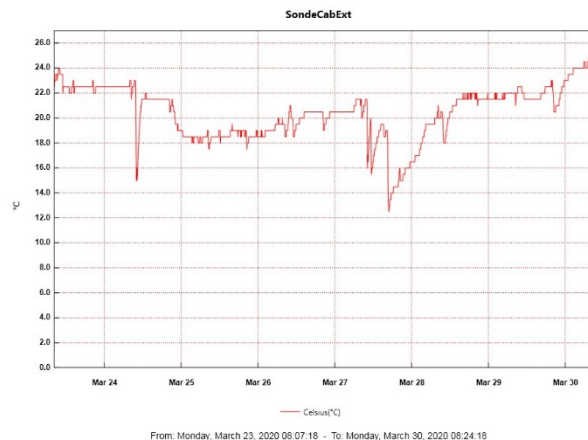
- 2020-03-24 0000Z: The sonde that was prepped initially terminated inexplicably prior to launch. Prepped and launched a second sonde within the usual launch window.
- 2020-03-26 1200Z: Retried the sonde that had failed on 03/24 with the same results. Retired this sonde to the “box of broken dreams”.
- 0000Z sondes continue to have lower burst heights than 1200Z sondes, including some burst heights below 15km.
- See charts below for temperatures inside and outside the radiosonde cabinet over the last week.
