ICECAPS-ACE Weekly Report

April 27 – May 3, 2020 Nate Bowker

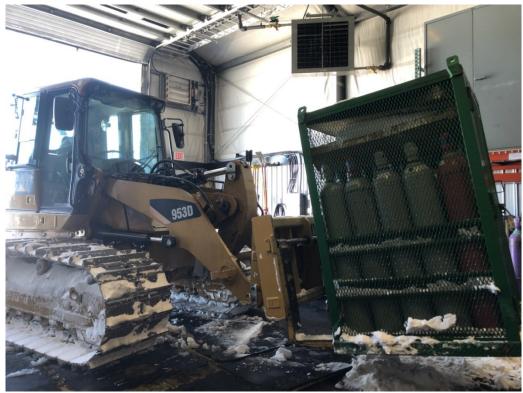
Moving empty helium cylinders out of the SMG in preparation for next week's incoming helium shipment. Photo Kathy Schroeder

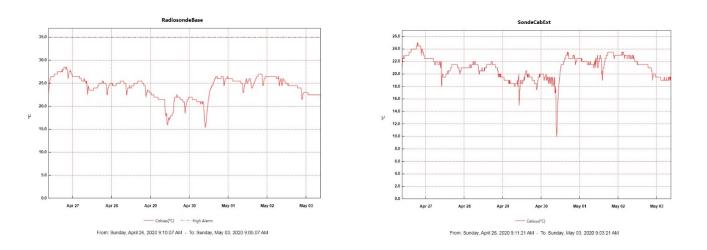
- 2020-04-28 1200Z: Sounding terminated due to "excessive missing data frames". Distance from station at termination: 107.9km.
- 2020-04-30: Removed 50 empty helium cylinders from the SMG and brought the last 25 full helium cylinders on station into the SMG.
- See charts below for temperatures inside and outside the radiosonde cabinet over the last week.
