# ICECAPS-ACE Weekly Report

June 8 – June 14, 2020

Ian Geraghty

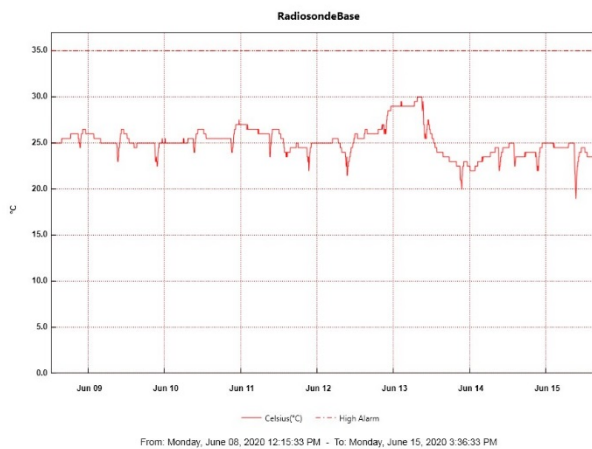
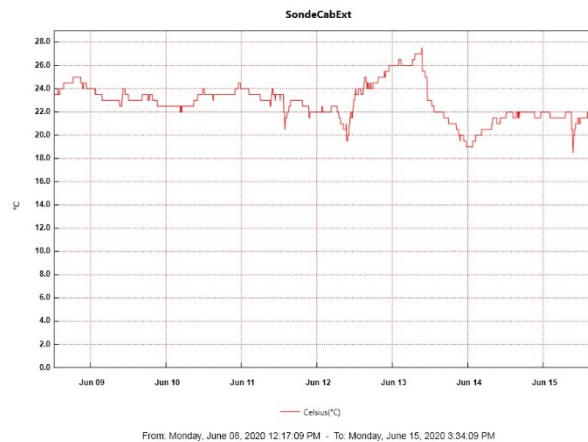
- 2020-06-13: SPS was found disconnected prior to 1200Z launch. Temperature in the cabinet was ~30°C. SPS reconnected after Mara power cycled it.
- 2020-06-14: Data from 0000Z launch failed to be transferred to DMI. Possibly due to a brief network outage.
- See charts below for temperatures inside and outside the radiosonde cabinet over the last week.
