ICECAPS-ACE Weekly Report

May 10th – May 16th, 2021

Dane Hansen

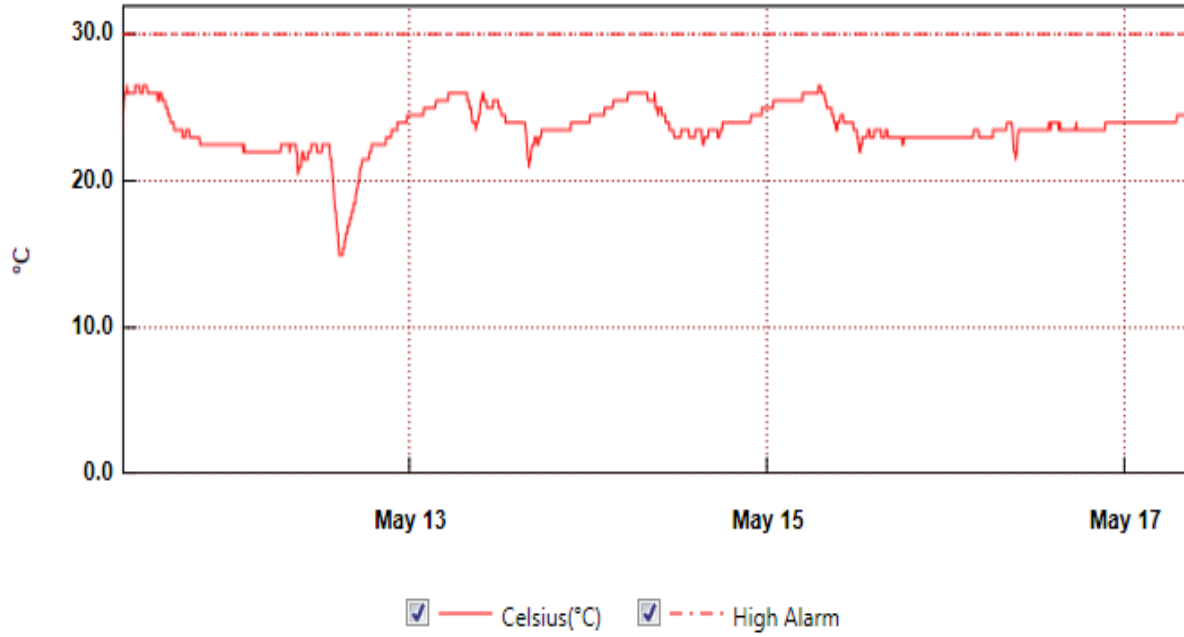
RadiosondeBase

- Once daily launches.
- Intermittent SPS connection lost errors.
- See chart below for radiosonde cabinet temperatures over the last week.
