# ICECAPS-ACE Weekly Report

July 19<sup>th</sup>– July 25<sup>th</sup>, 2022

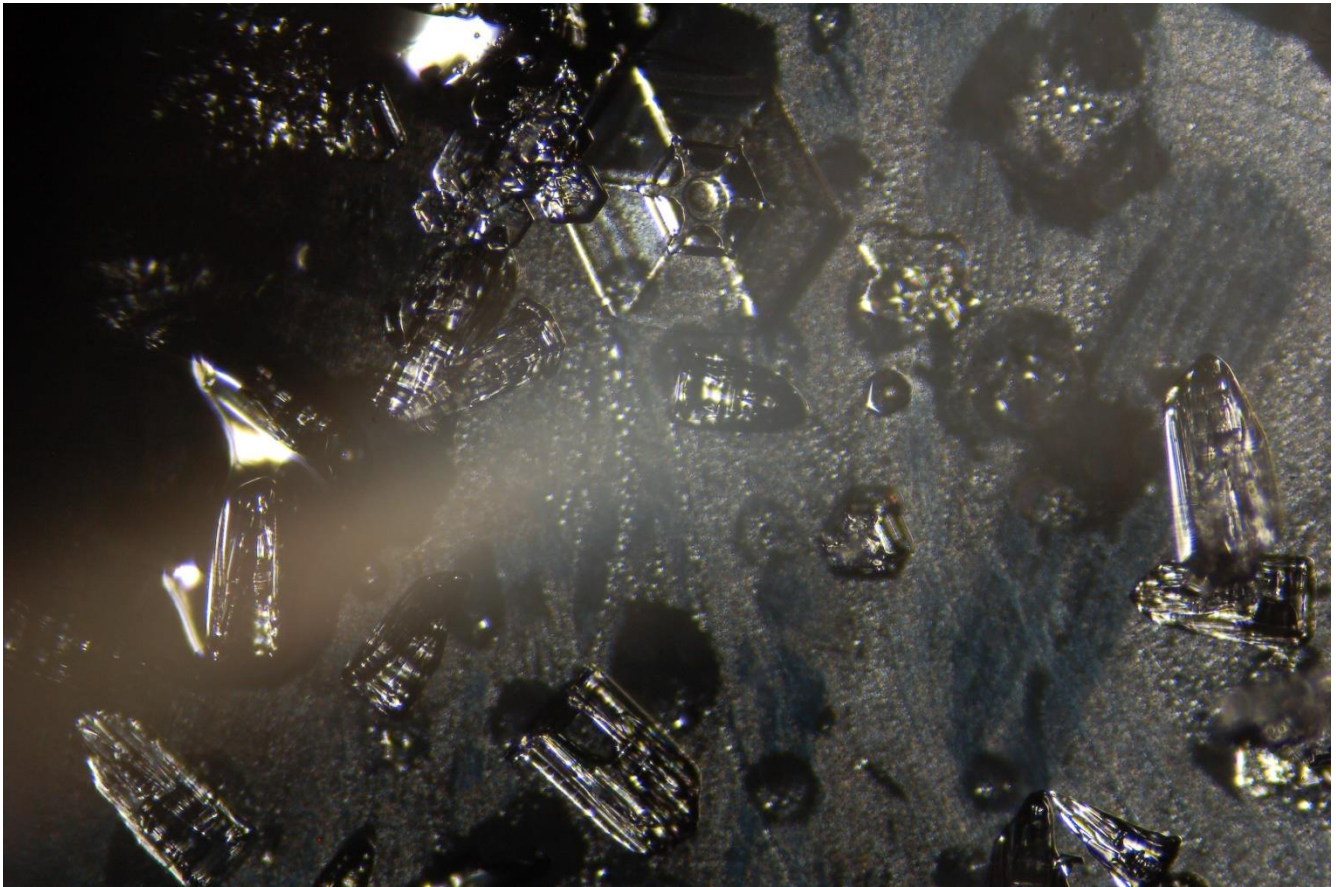
Ice PIC image captured during snowfall 2022-07-22
