Radar Update
Claire Pettersen
April 4th, 2012

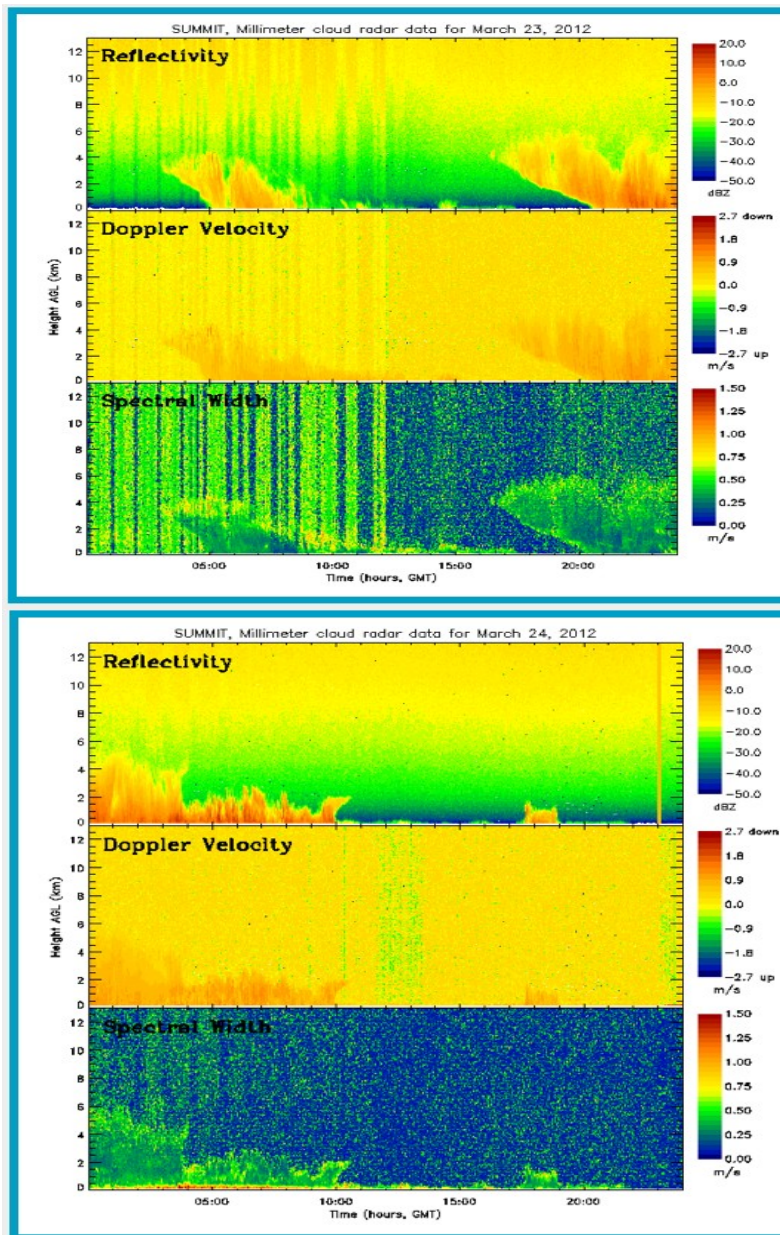
From March 19th to 22nd, the old Up Down Converter was removed and the new Up Down Converter was installed. An extra attenuator was added to the back of the Radian box at the Transmitter Output (51-10dBZ) and the UDC was tuned using the power output of the TWTA. The “I” signal from the Radian Box was low – 20mV peak to peak. You can see the results did not look good from the NOAA radar browser images below (March 23rd and March 24th). Black flexguide piece was replaced as well. No change:

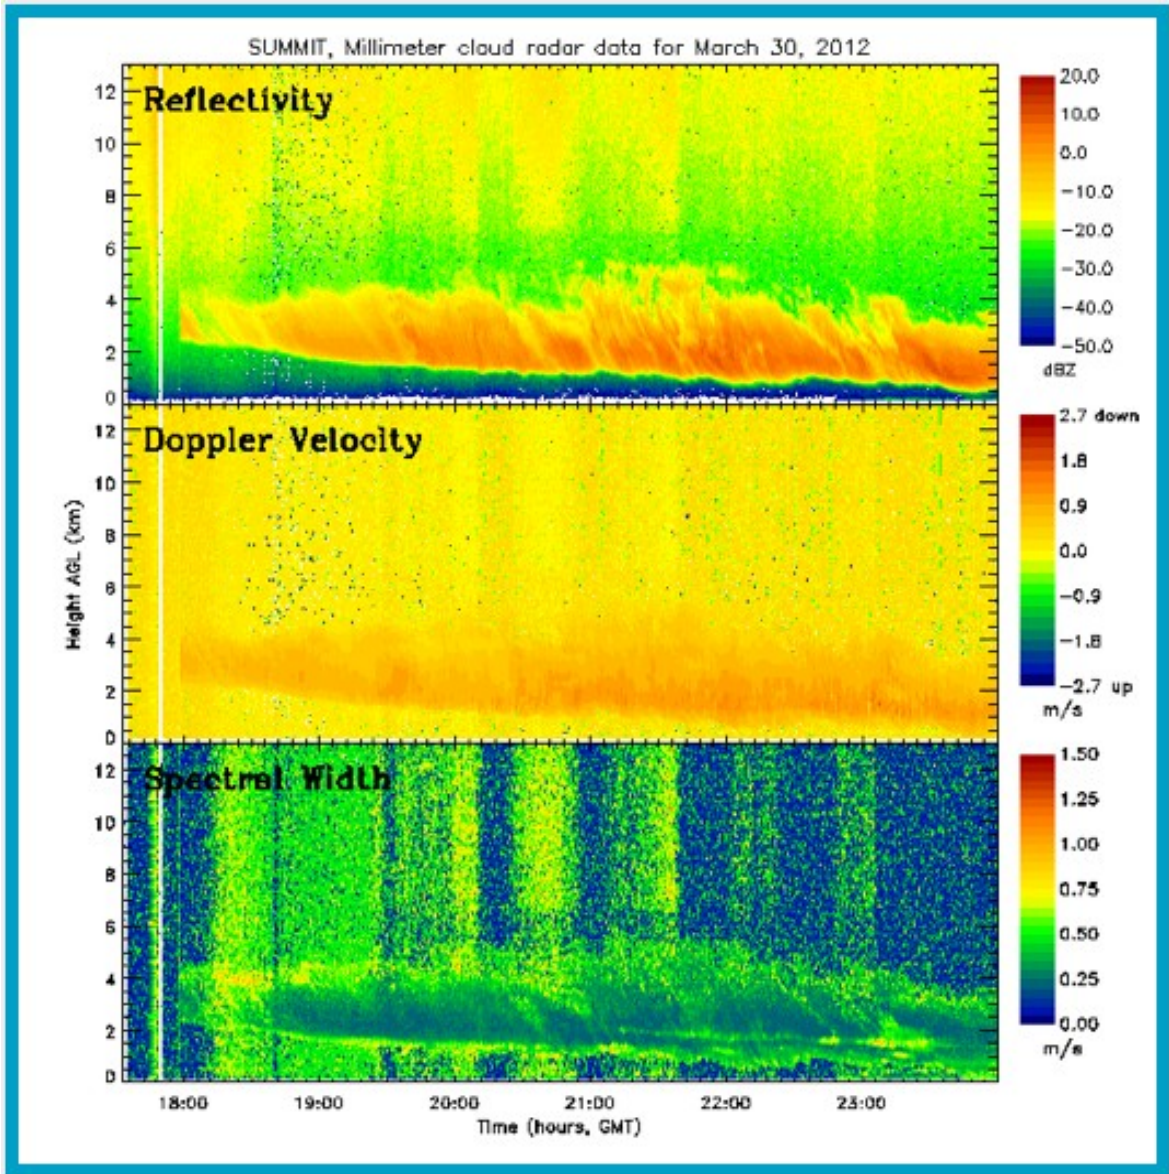
Waveguide setup was rebuilt in the old configuration and each waveguide piece was inspected and cleaned. There were 5 junctions missing screws and 7 junctions with loose screws. There was little to no change in the radar performance as seen in the March 30th browser:

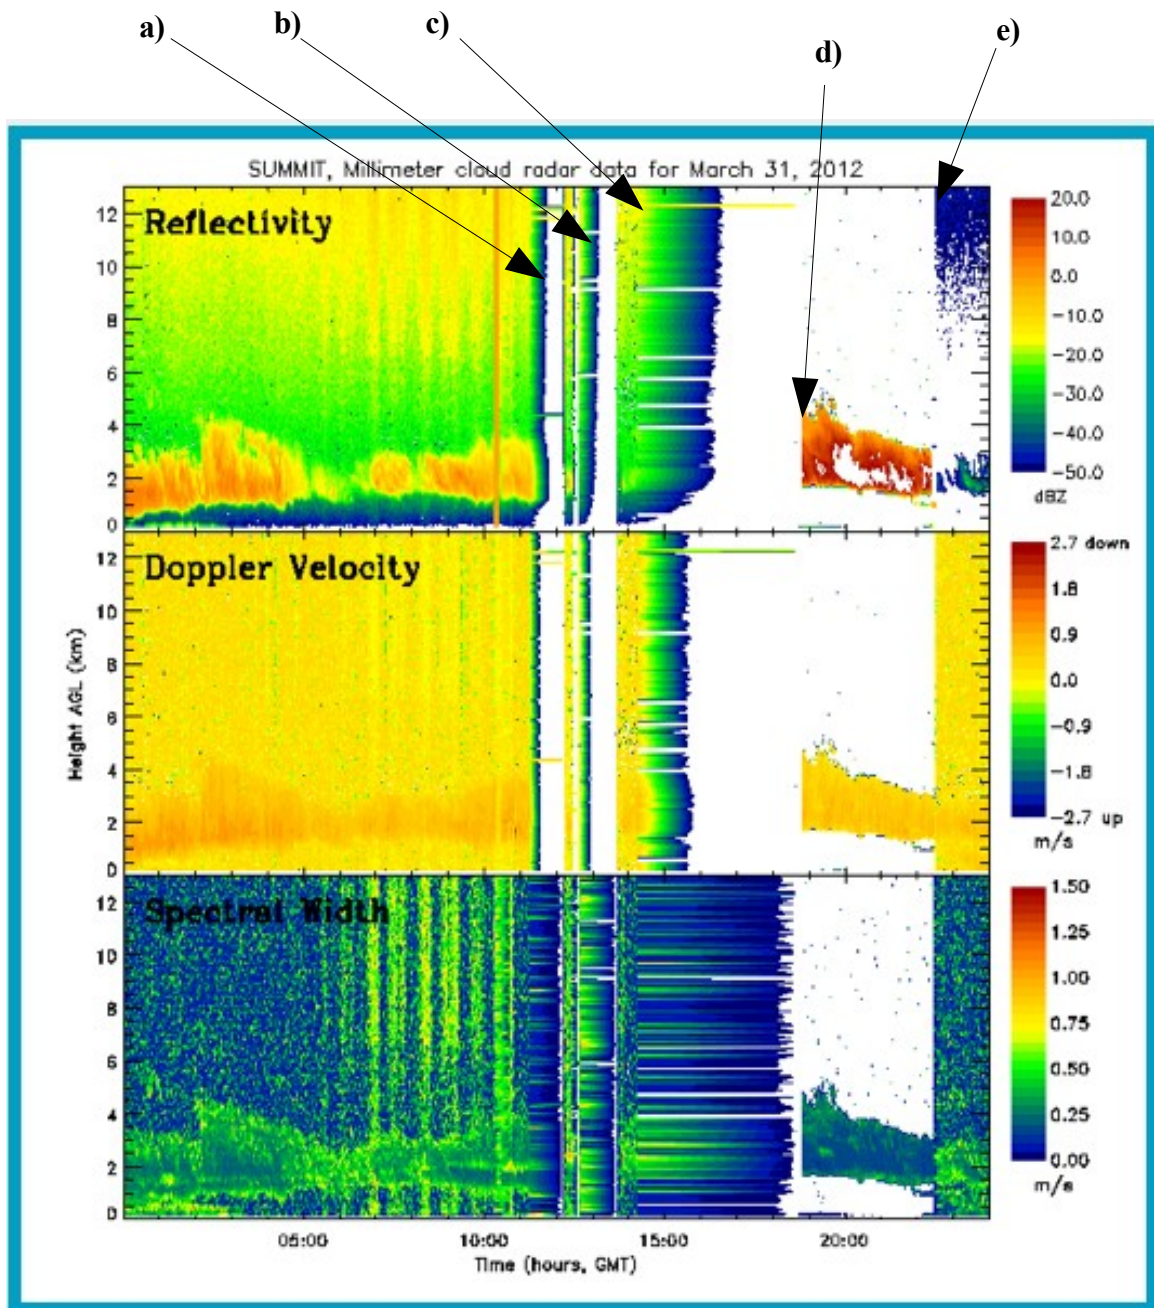
See the figure below for the correlating timing. During the day I first: **a)** turned off radar, replaced the black flex guide from the RF Input of the UDC with a piece of gold flex guide, turned on the radar - no change, **b)** turned off radar, replaced the gold flex guide with a piece of brand new bubble-wrap protected black flex guide, turned on the radar - no change, **c)** shut down the radar, went to lunch, did work on the roof and PAERI fan (nothing related to radar), **d)** started radar back up – high reflectivity but no background scattering and the noise floor is about 38dBZ – which is where it should be (the only thing I saw change at this point was that the “Circulation Temperature” was above 0C), **e)** at about 2230 UTC, Duane does some type of calibration – the noise floor drops to 20 dBZ (thus we have background scattering again, but is much improved). Since the following day is the first of the month, we will wait for the Full Calibration to run on April 1st:

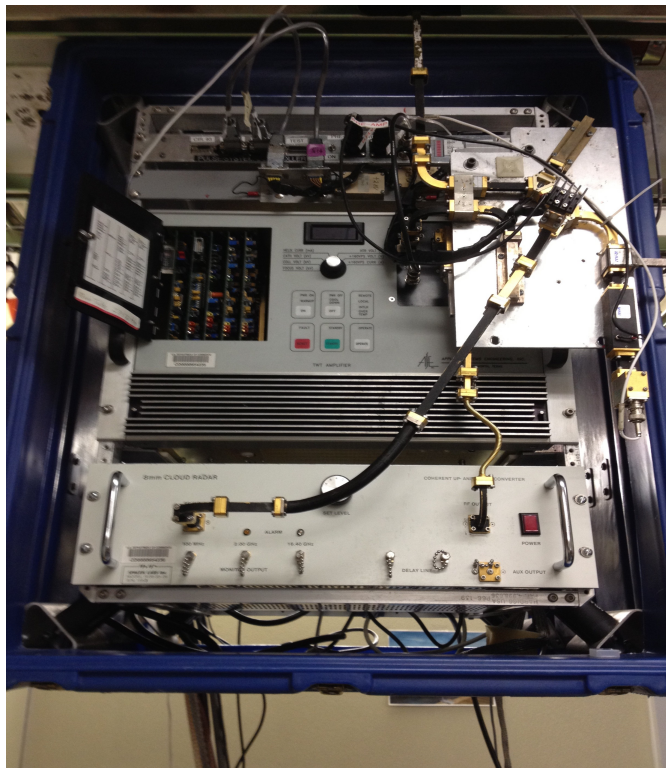
This is a picture of the waveguide setup when I arrived:

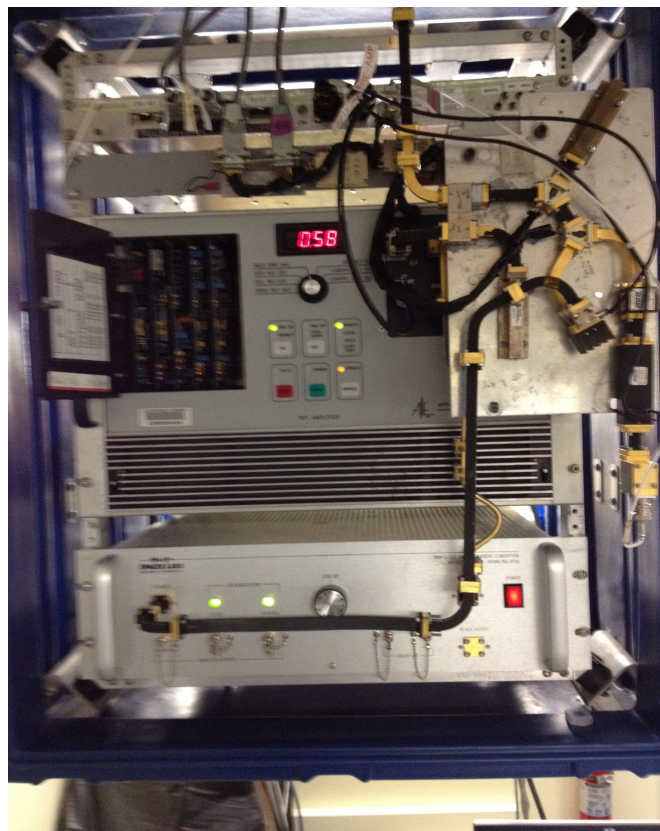
And this picture below is the CURRENT waveguide setup (copied the old setup from last Summer):

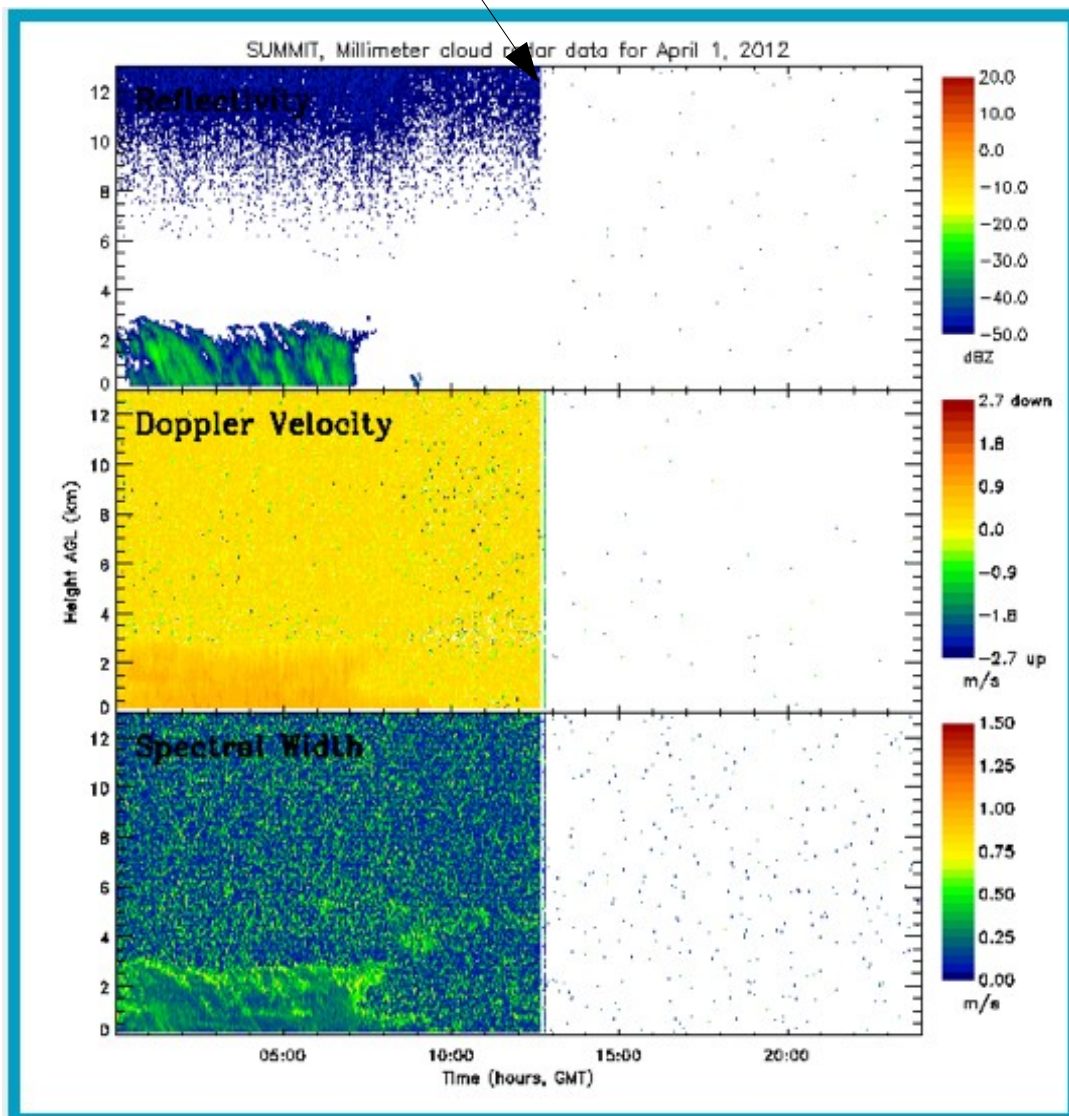
A

Duane calibrated the radar the previous day (at 2230 UTC March 31st). I woke up at 8am local (1000 UTC) to a severe clear sky (clearest we have had since I arrived). I checked the radar and it only had the scattering – no clouds at 1000UTC. The big Monthly Calibration at the first of the month was automatically run at 1230 UTC (A in the figure below). At this point (A), one can see the scattering has disappeared. Also, the noise floor is back to 38 dBZ on the spectrographs on mmcr-radar, which is close to where it should be, and the signal from radian box BNC “I” is about 200mV peak to peak, which is also where it should be. However, the big calibration **FAILED**. **But, some settings must have been changes by the Monthly Calibration even though it failed because the noise floor changed and the “I” changed to close to their correct values, 38 dBZ and 200mV, respectively.** Since there was no cloud cover, we let it run all Monday as well in the current state.

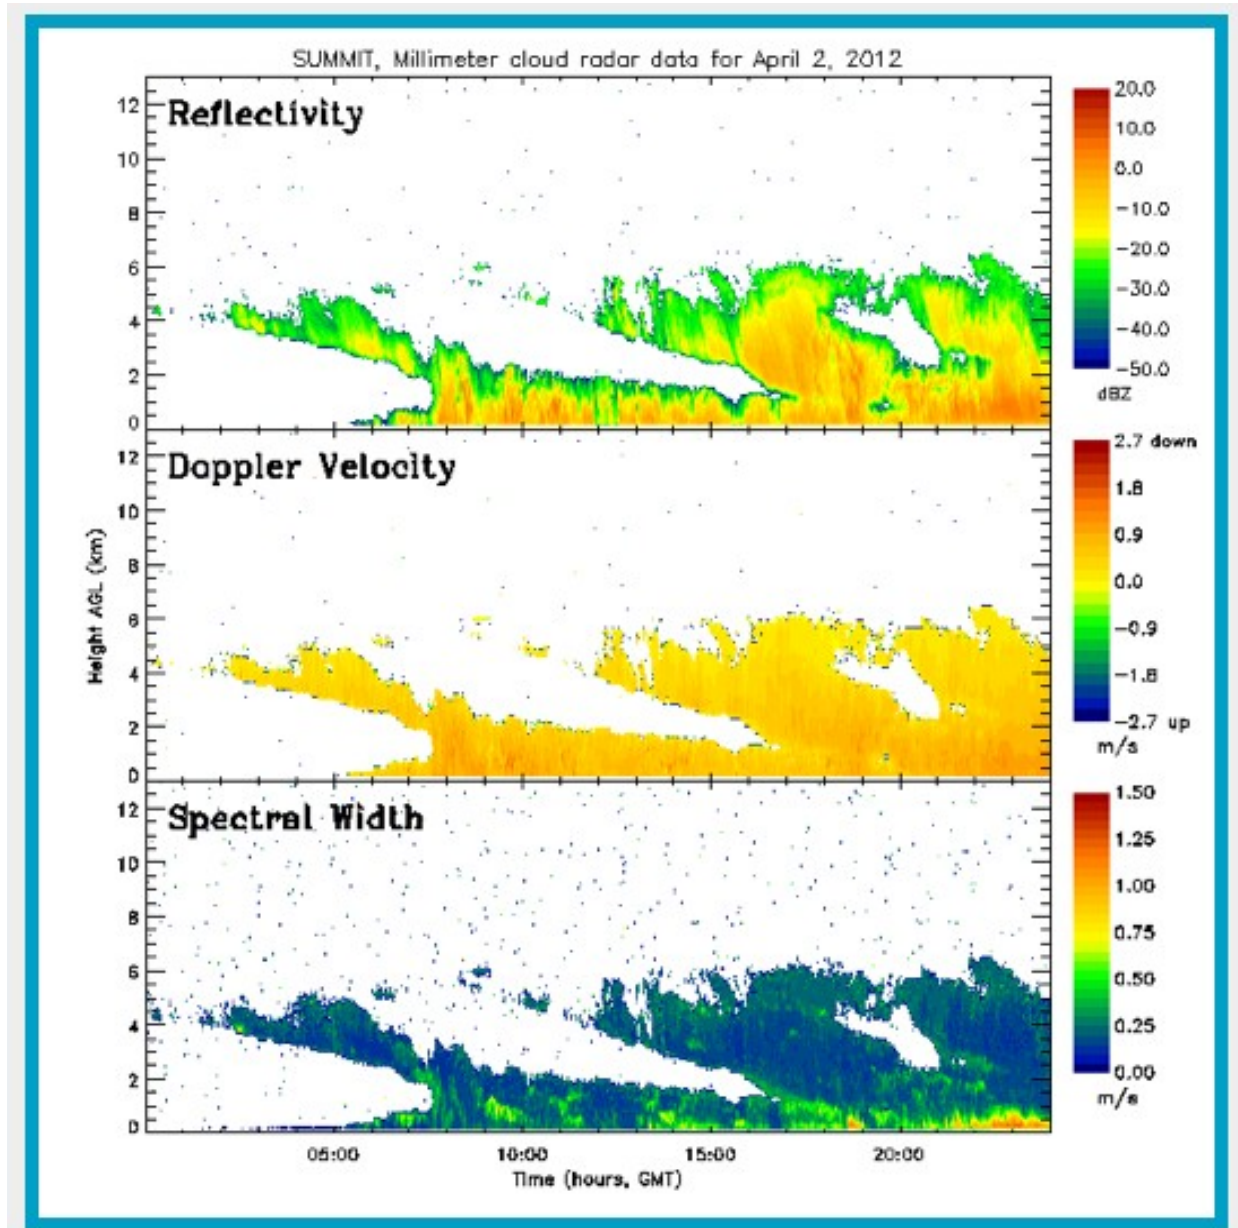
We had an overcast and snowy day on April 2nd – the data looks great on the browser. Whatever changes from the big calibration – even though it failed – made the data look the best it has been since last last fall. The reflectivity seems to match the outside conditions. However, the big calibration did fail but the changes it made seem good:

- The Monthly Calibration, though failed, seemed to bring about the correct parameters for the radar. For example, the resulting data on April 2nd, the noise floor of 38dBZ, and the “I” signal of 200mV peak to peak. You can see the data looks good after the failed Monthly Calibration in the graph from April 2nd.

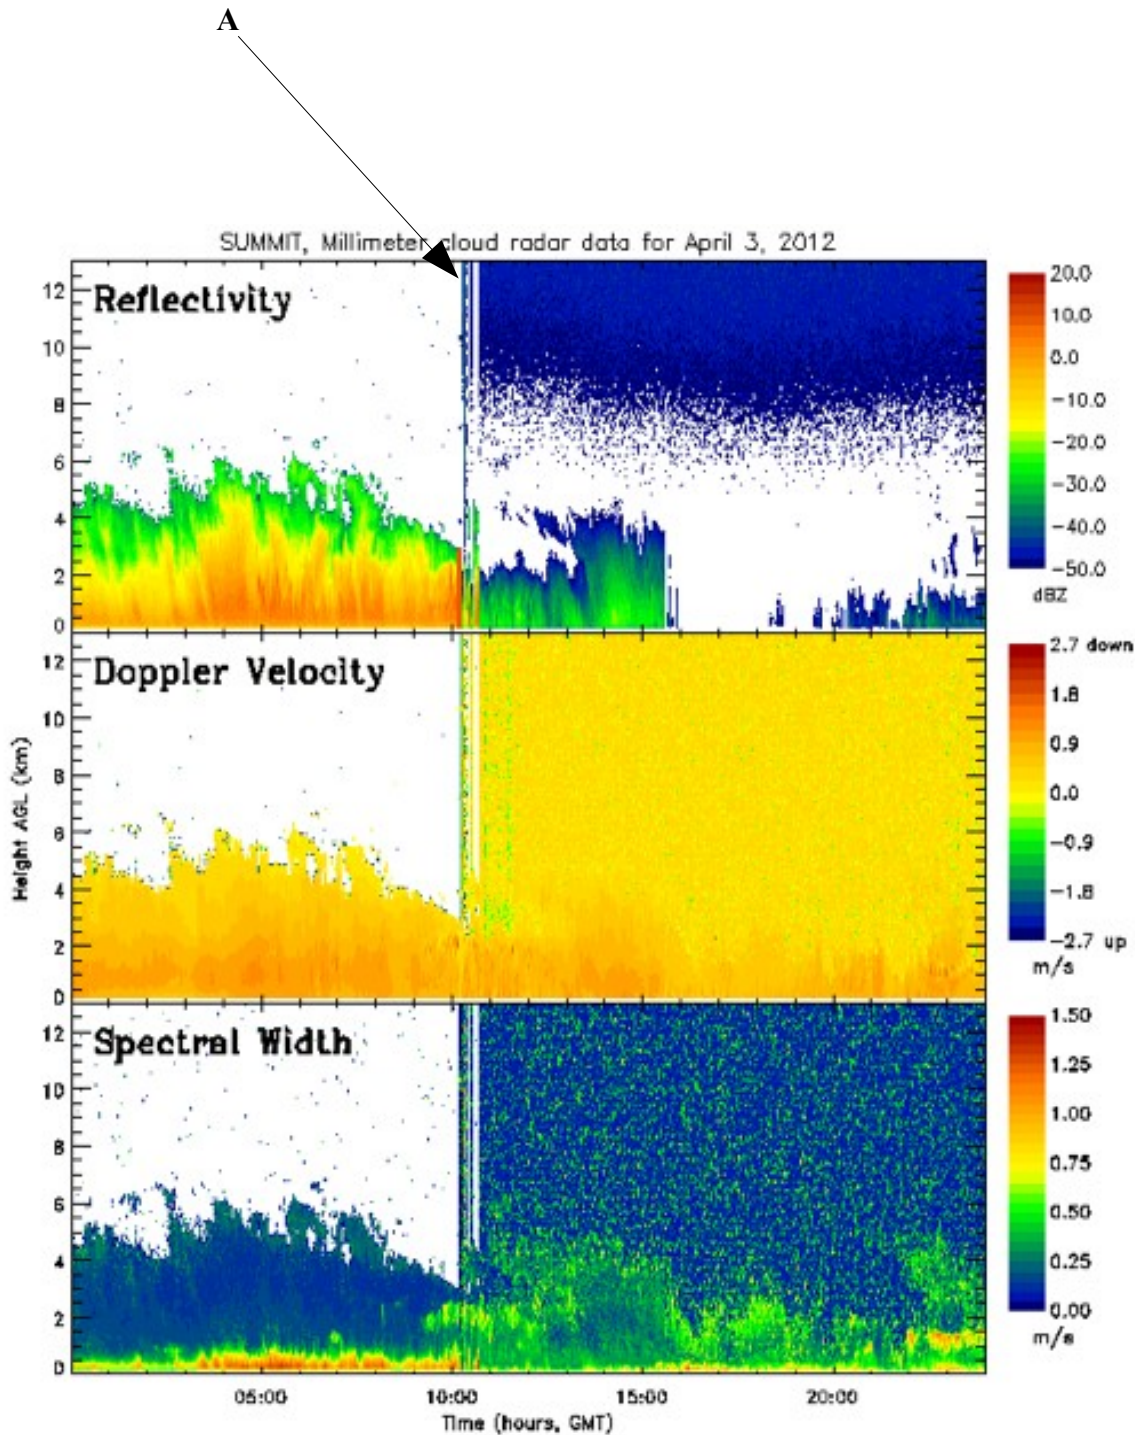
Duane ran a calibration (different from the Monthly Calibration) in the morning April 3rd at about 1030 UTC (point A). This calibration again lowered the noise floor to about 20 dBZ and the signal from “I” is a order of magnitude lower, about 10mV (it should be 200mV as it was after the big calibration failed). We again have background scattering. The weather on both April 2nd and 3rd was exceptionally snowy and overcast for the entire day (the heaviest snow I have seen here).

- For some reason, the current calibration that Duane has been running succeeds, but lowers the noise level to 20dBZ and the “I” to 10mV peak to peak. You can see this effect in the graph from April 3rd at 1030 UTC (**A**).

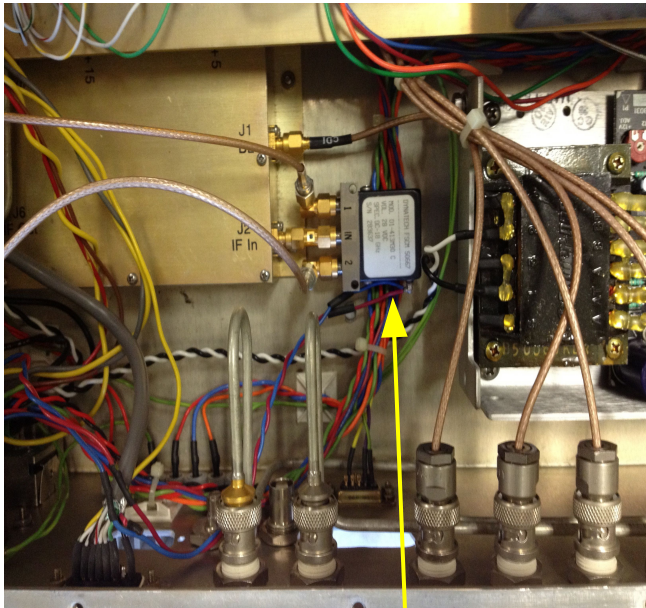
Before: With switch

Duane and the radar design engineer concluded that the calibrations were not working due to a bad switch in the radian box that is used during the calibration. I removed the switch from the radian box and bypassed it completely as per their instructions. The radar was shut down at 1600 UTC on the 4th and brought back up at 2030 UTC the same day. The switch is illustrated below:

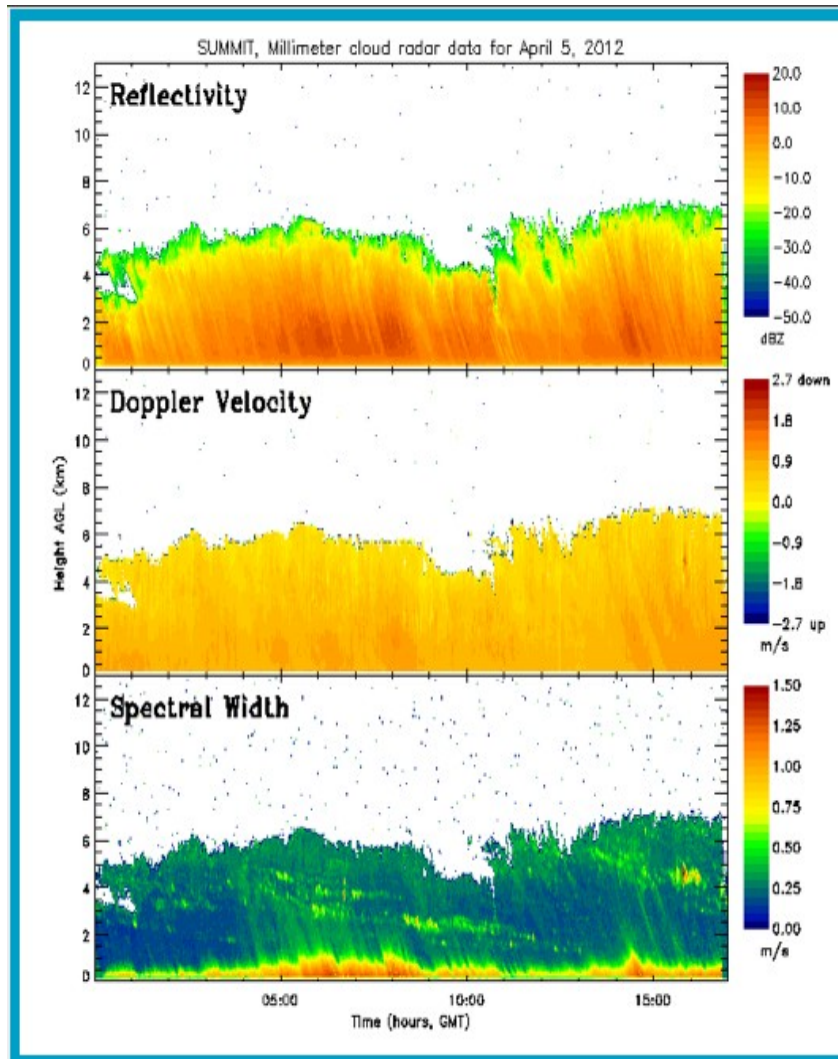
On April 5th at 1035 UTC, the Up Down Converter was switched to “3”. And the cal-table was changed on 0000 UTC April 5th to accommodate the new setup without the switch:

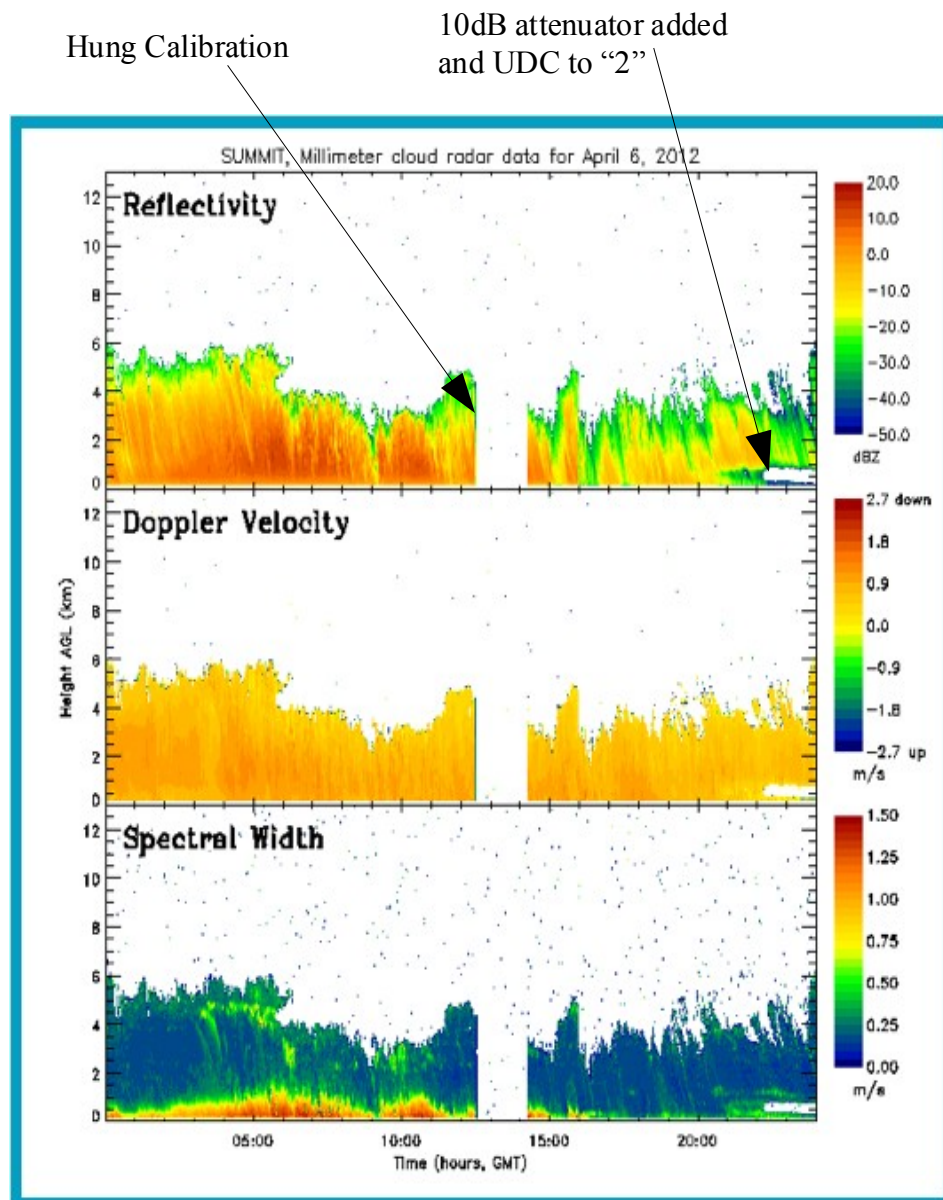
while we have made some good progress on the radar, we are not yet where I want to be with it. I've been looking at some of the Doppler spectra today in more detail and there are some serious images in the data. I won't go into the details of these (in part because I don't understand everything about them!) but the images used to be about 36 dB down from the primary signal and now they are more like 20 dB down. This leads to incorrect moment calculations. I could write some code to correct the spectra and then re-compute the moments, but ideally I'd like to get these images back down where they should be.

So, Duane and the radar design engineer asked that a 10dB Attenuator be installed in the Input into the radian box as well as the UDC be changed to "2". This was done at 2230 UTC:

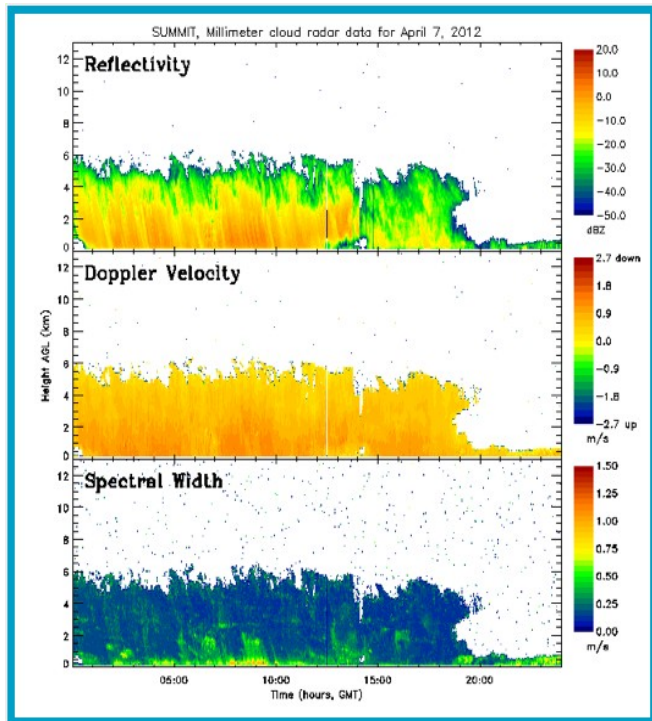
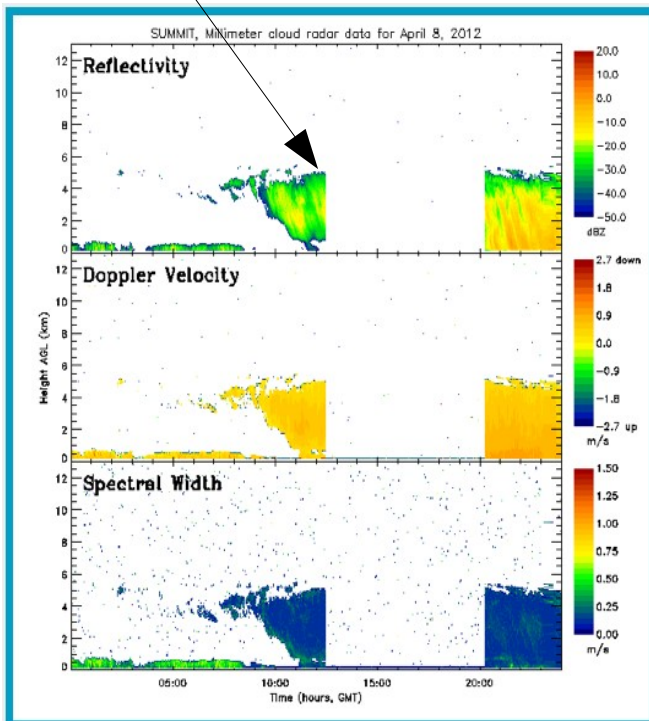
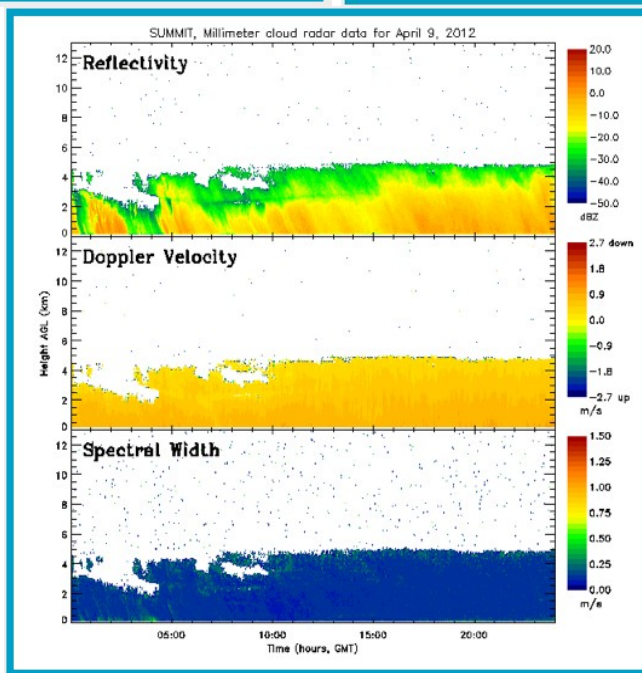
Helix Current Fault TWTA

On April 8th (Easter Sunday), we had a Helix Current fault in the TWTA after the calibration check at 1230 UTC. This led to a loss of data for a few hours. We now have a procedure for correcting this fault in the Daily Checks – common problems section.

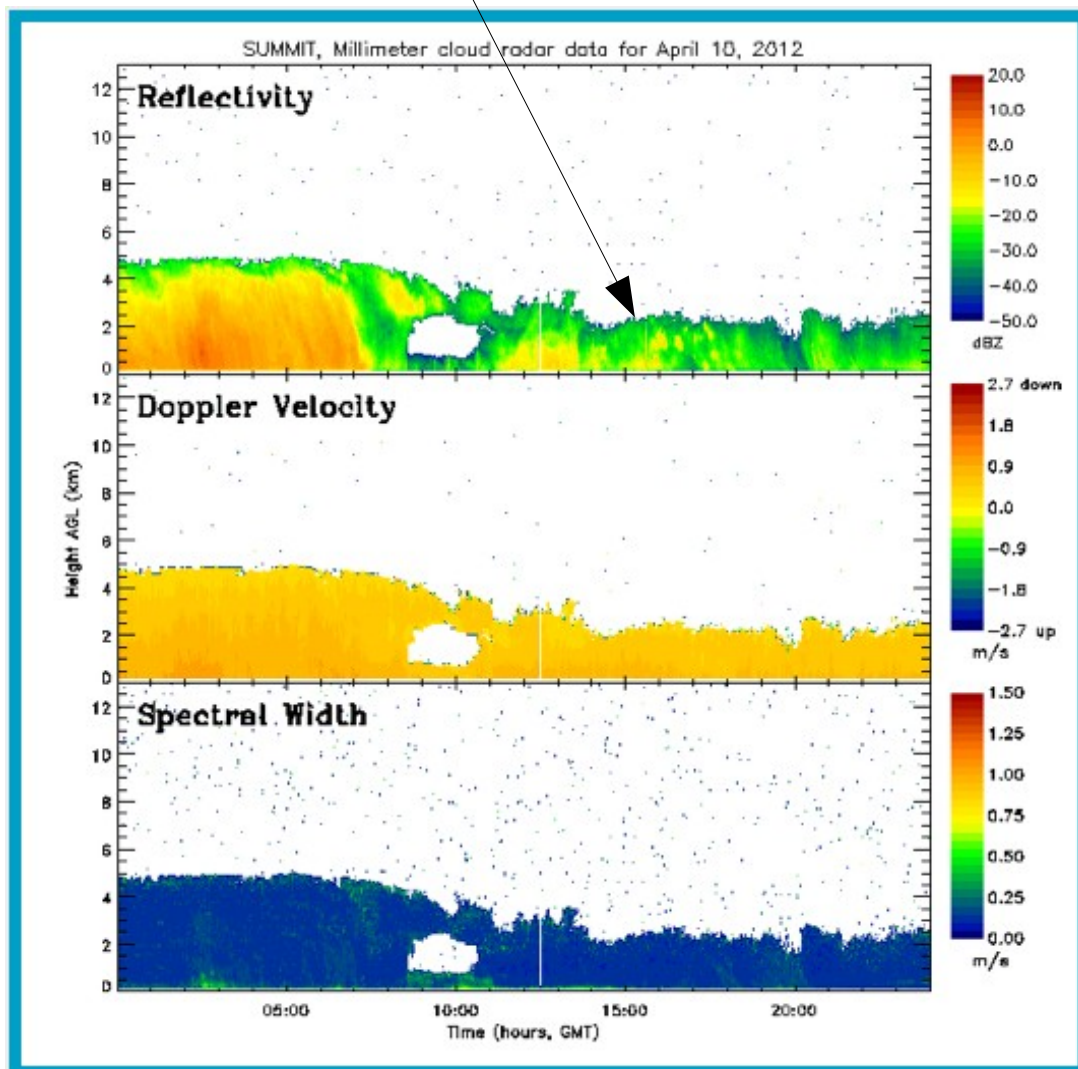
Approximate time of debugging work

On April 10th, Duane asked for some debugging work. First, from 1536 to 1540 UTC, I watched the “I” and “Q” signals on the scope while I removed the 10dB attenuator from the Receiver Input line and then placed it back in the line. Second, from 1540 to 1542 UTC, I removed “I” and “Q” BNC cables from the back of the radian box and observed the change in the noise floor. The noise floor went from 27 to 36dBZ to 6 to 14dBZ (when “I” and “Q” were unplugged).

After finishing this, I noticed on the spectrographs that the mirror images seemed lower dBZ than before. Again, nothing was changed, but my suspicion was that the BNC carrying the receiver signal (in braided aluminum ground shield outside the BNC), was either a bad cable or that the shield was not properly grounded. I emailed Matt and Duane with my observations, however, there was not a lot of cloud/moisture action on April 10th, so it was hard to tell if the images were actually lower. Matt would need to do some more analysis.

- The mirror images' drop in dBZ (from only 20dBZ lower to down to 31dBZ below primary signal), seems to be tied to the BNC cable for the Receiver Input. This cable is shielded with an aluminum braid and it is possible it is not properly grounded. If the mirror images get high again, I would recommend checking that cable and grounding the strap.

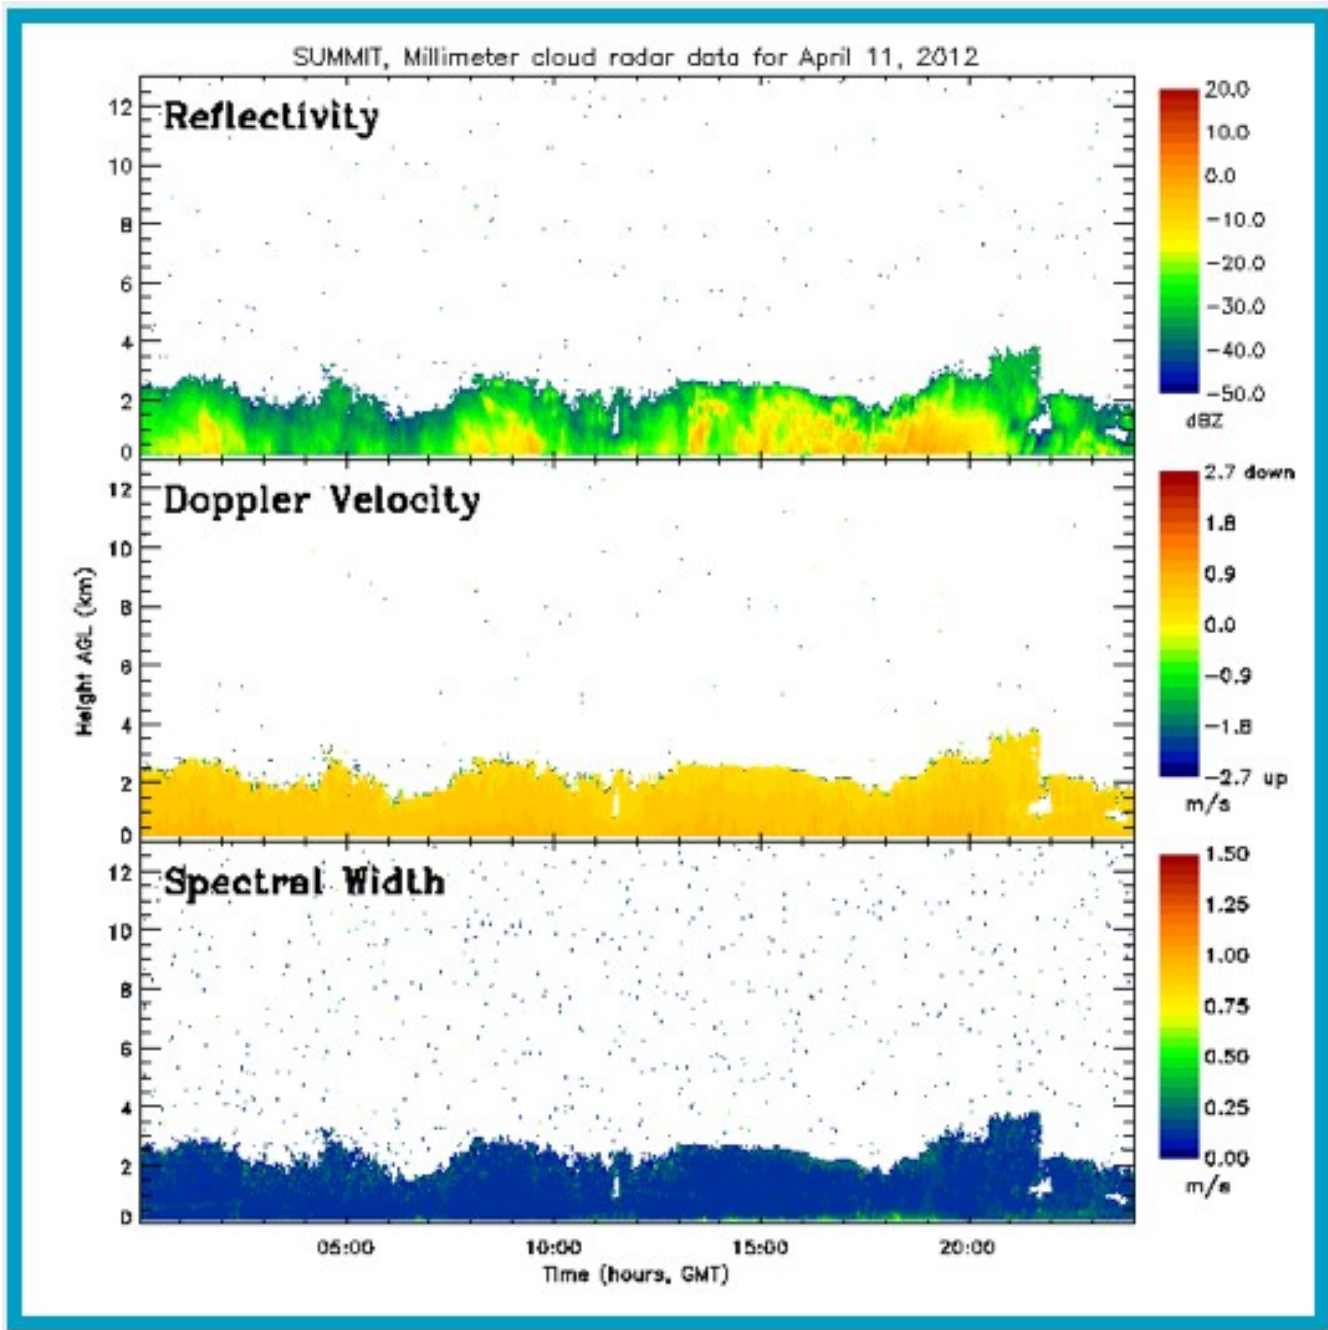
GOOD DATA!

On April 11th, Matt verified during the call (and again on the 12th), that the images were back to being about 31dBZ lower than the primary signal. And that the radar data looks really good. Duane will continue to work with the calibration to get it to a point where the daily cal checks are not failing (however, the calibration on the radar looks good, there are errors due to removing the switch in the Radian Box).
