Troubleshooting the INTRA at Summit

After reading the mails and their attachment, there are some puzzling questions left – or in short: We still do not yet understand what exactly the problem of the Summit-INTRA is. According to the log-file Tracker_log_10_31_16.docx, it worked normal until 21.09.2016. Then it produced “near zero timed out errors” until 25.10.2016. On this day, the rewind operation was executed correctly and this continued until 30.10.2016 when a “zero-0 timed out” message came up. But it recovered and completed the “search flag run” less than 2 minutes later. However, with a unsettling value of 9380 for the parameter eposo. Now let’s first discuss what these messages tell us and then which questions the current set of data leaves open. But firstly a few words about basics of the tracker:

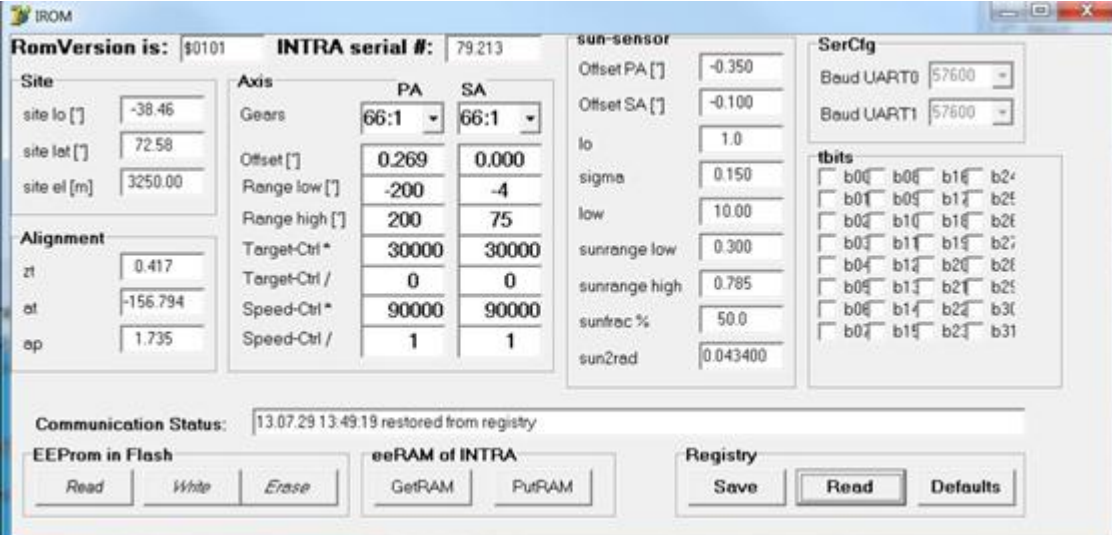
On 25.10, there was an intervention. On Dany’s request, we connected a laptop to the DB9 port in the lower power supply box of the tracker. Using IntraCfg, we re-sent the EEPROM flash settings specified by Dany, used the ‘Run Motors’ mode to confirm that the unit could move in both axes, and selected the ‘Sun’ mode. The tracker appeared to resume operation, pointing at a location near the point where the sun had set (near the horizon and to the south). When we checked the tracker the next morning (12z), the tracker arm pointed about 165 degrees behind the sun in azimuth, and at roughly the correct elevation. The EEPROM settings sent on 25.10 were as follows:

rbw: The above values in the eeprom are those for the controller board that was used until June 2016. This can be seen from the serial number. When I installed the new board (#252) in June, I edited the serial number accordingly and also changed the I0-value from 1.0 to 5.0. The low value for I0 may cause problems during low elevation or partially clouded conditions, because low level signals on the sensor that should be discarded are considered valid and lead to wrong movements.

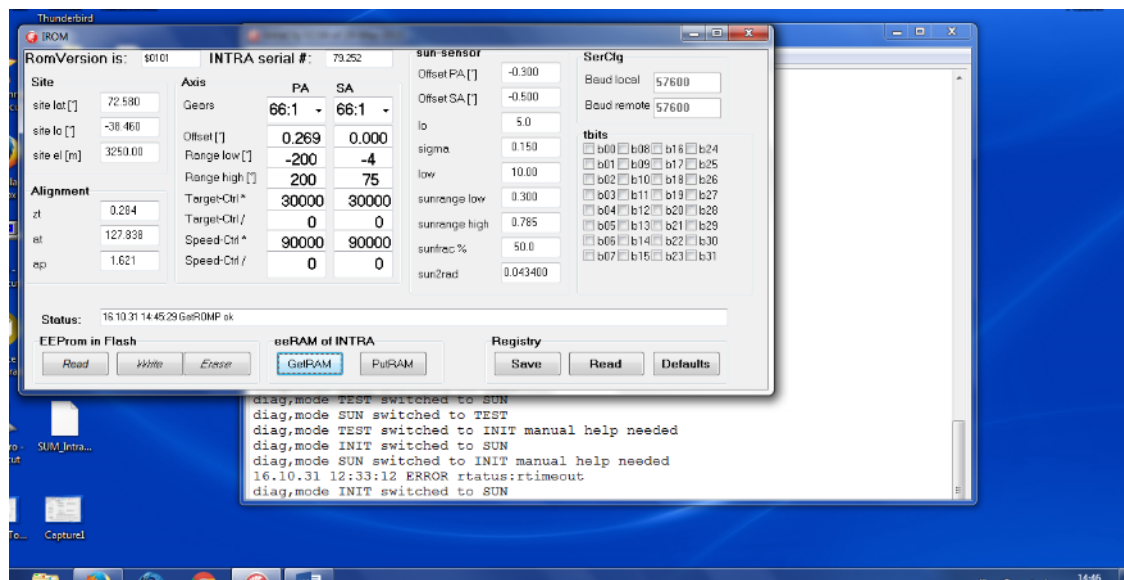
I will confirm the number of zeroes in the 90000 and 30000 fields each time I connect to INTRA. You can see in the following screenshot that we entered the correct numbers on 31.10.

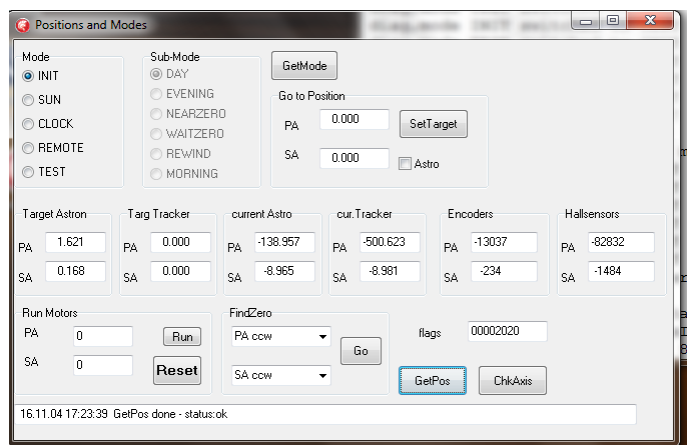
See attached screenshot "GetPos_request"

Estimated elevation: -10 degrees

Estimated azimuth: -140 degrees (140 degrees counter-clockwise from South)

cur. Tracker PA = -500.623. Now $-500 + 360 = -140$ which corresponds to the observed estimated azimuth. Hence one full turn below where it should be and way below the -200 limit imposed on this axis. Similarly, the SA is outside its range [-5..75]. It looks as if parts of the firmware of this tracker is corrupted.

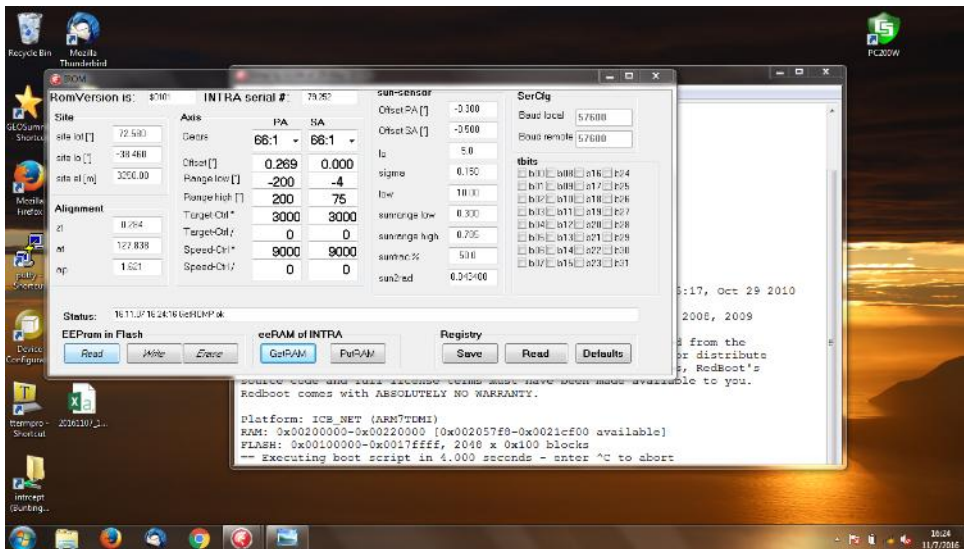
A screenshot of the EEPROM parameters is shown here:

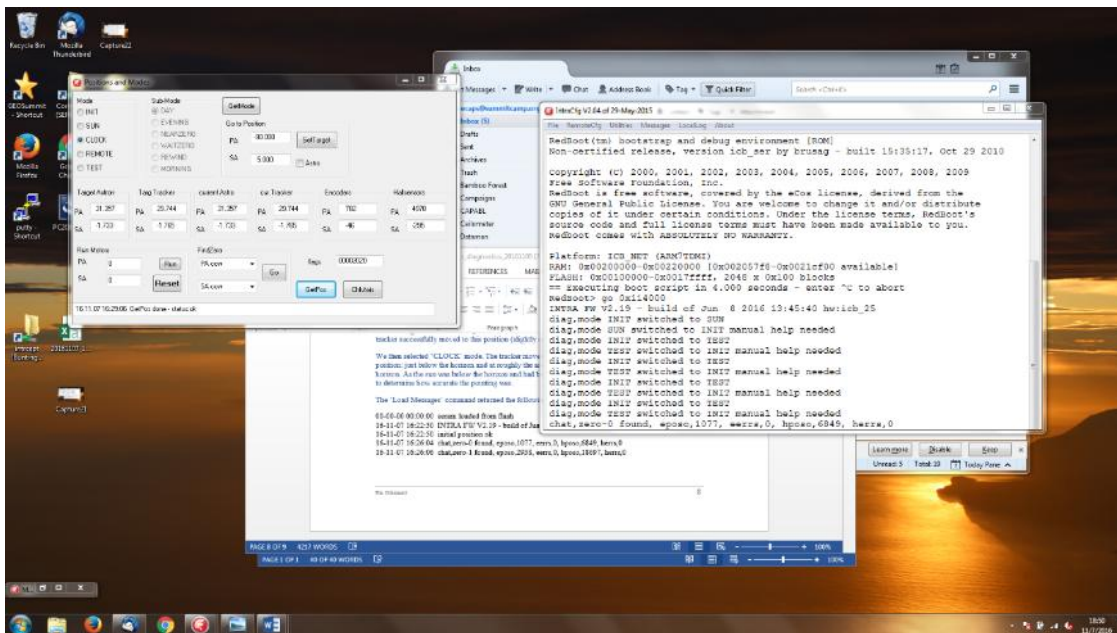
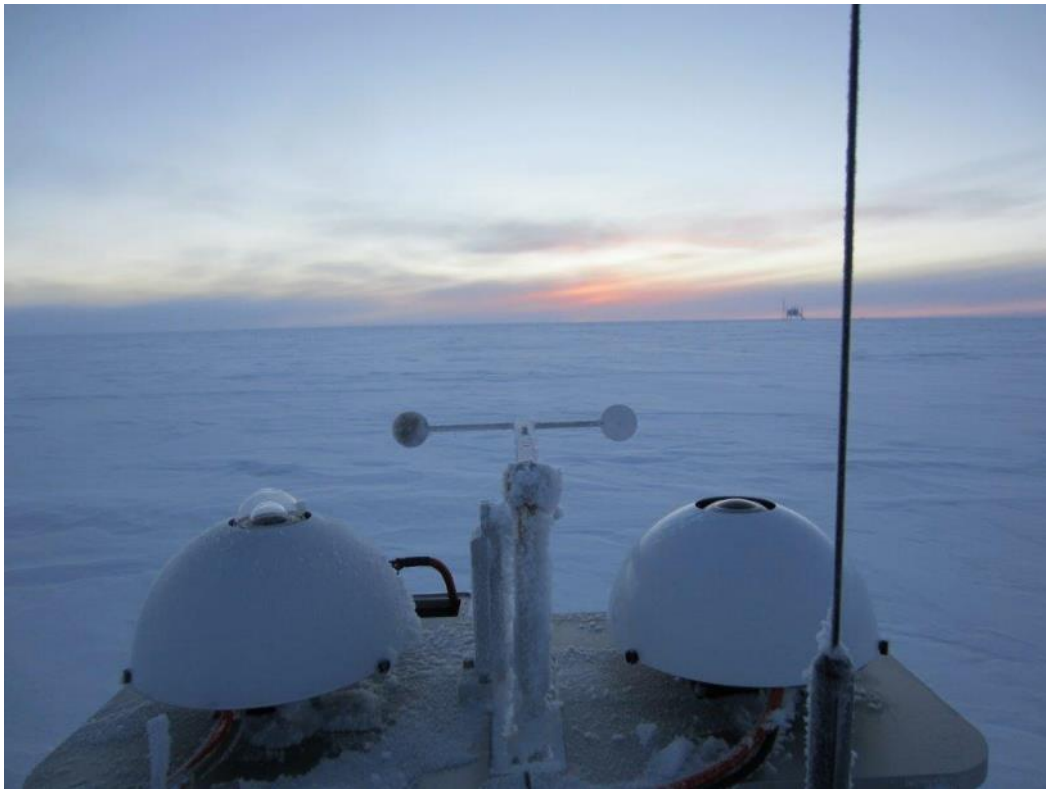
We then selected 'CLOCK' mode. The tracker moved to point approximately to the sun's current position: just below the horizon and at roughly the azimuth at which the sun had passed below the horizon. As the sun was below the horizon and had been partly obscured by low clouds, it was difficult to determine how accurate the pointing was. A screenshot and photo of the resulting position is shown here:
