ICECAPS Weekly Report

December 2 – December 8, 2013

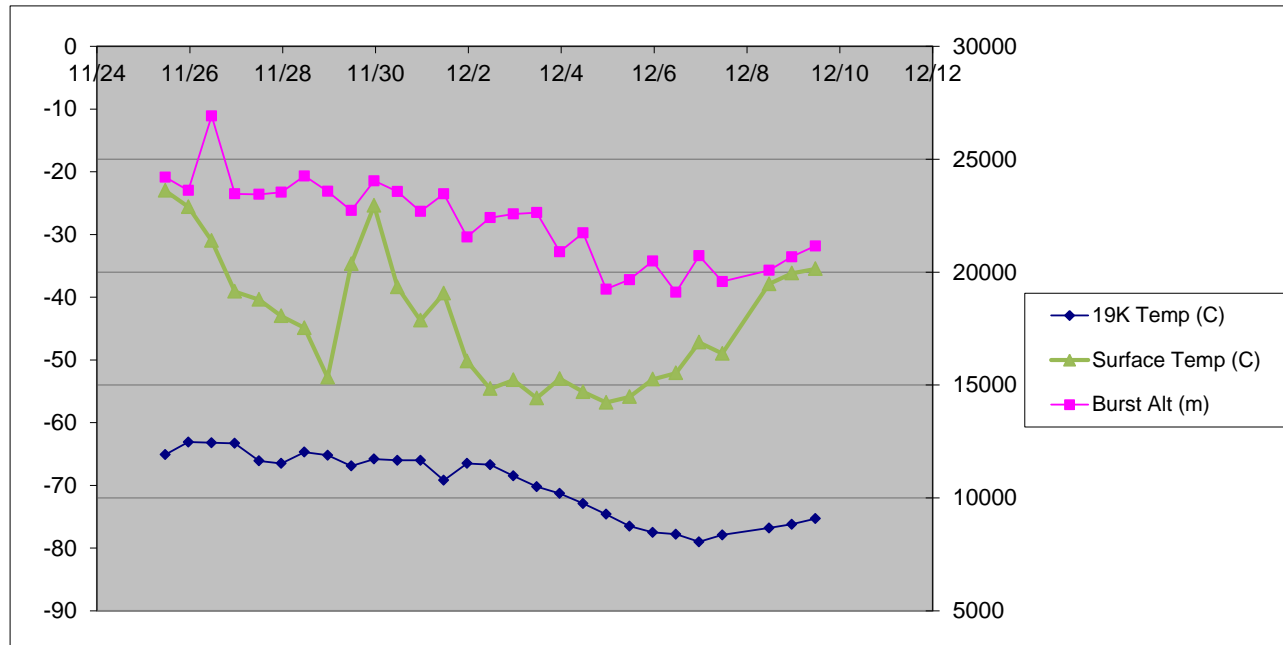
Burst altitudes have dropped abruptly to 20km and below this week, with no change in method or equipment (inflated balloons are still given 15-25 mins to equilibrate in SOB). Burst altitude does not seem as responsive to surface temp at launch, but perhaps more closely correlated to temperature at altitude, which dropped in the last week?
