ICECAPS Weekly Report

May 15 – May 21, 2017

Hannah James & Marci Beitch

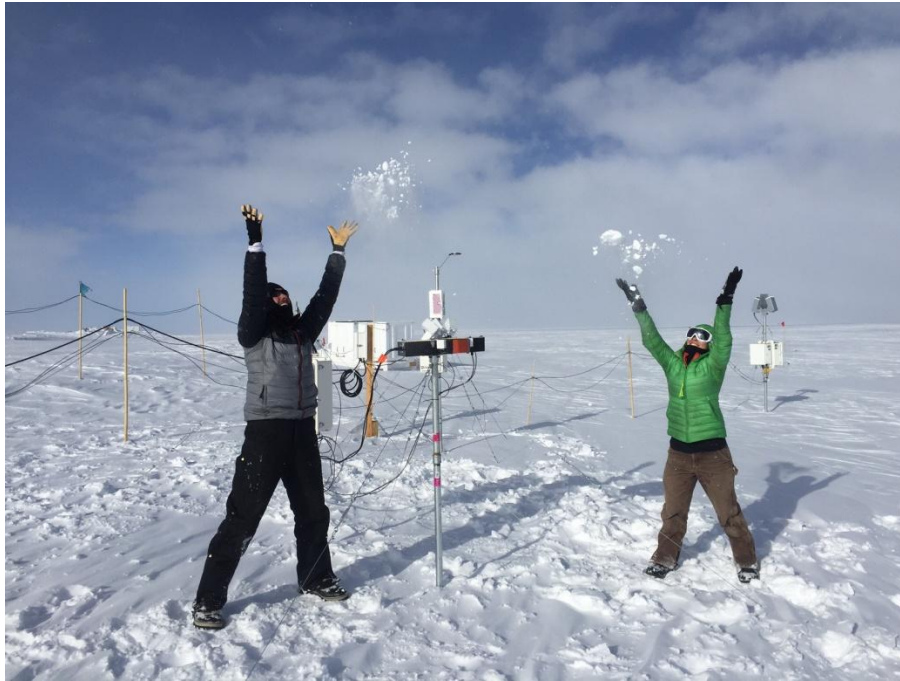
Marty and Marci celebrate the success of the MASC installation, while at the same time test the precipitation sensors. – HJ

- 05-17: Returned to station with Marty Martinez!
- 05-21: Installed, powered on, and collecting data by 18:00Z.
